Bulletin Ref: TB19a

## Ford Alternator Broken Wire

**AAL1797**

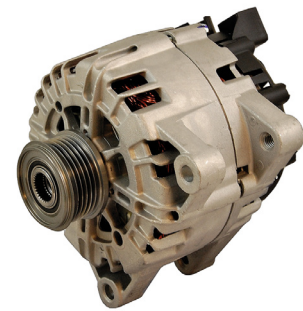
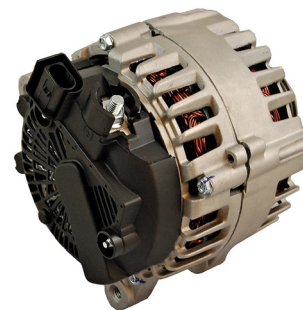
1. One Amp fuse is sometimes defective, this can be found in the main fuse box in the engine bay.
2. The wiring harness from factory is too tight resulting in broken wires in the harness, the wires are mostly broken under headlight.
3. Corrosion inside the multi connector on the rear of the unit is also common.
