TECHNICAL

BULLETIN

Bulletin Ref: TB11a

80amp Korean Fuse

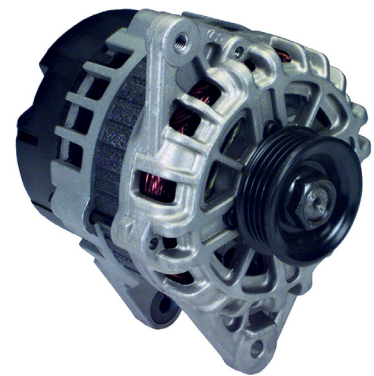
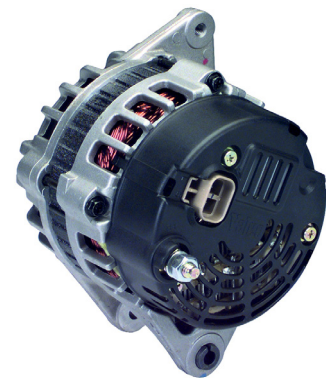
**Fig 1.**

Before fitting check the 80a PAL type fuse as this fuse can blow causing no charge. (Fig1.)

Also check for corrosion around and underneath the fuse connections which is common.
