Bulletin Ref: TB31a

Volvo

AAL1939

Common issues for charging problems.

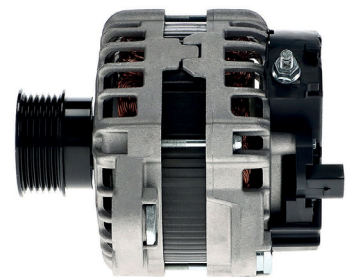
In some cases the ECU/PCM has corrupted software, the application will run on emergency program.

An ECU upgrade via main dealer software may be required.
