TSB #90

A-2647 LINCOLN NAVIGATOR (U326) FORD EXPEDITION (U324)

PROPER INSTALLATION AND INFLATION NOTICE

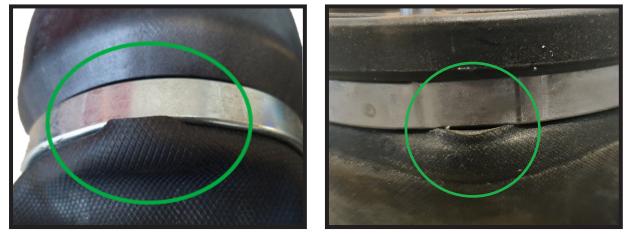
IMPROPER INFLATION EXAMPLES

Air springs inflated without following the manufacturer's specifications/not supporting the vehicle can cause the force to distribute unevenly, which may result in crimp ring failure.

PROPER INSTALLATION & INFLATION PROCEDURES MUST BE FOLLOWED TO AVOID PERMANENT DAMAGE TO THE PART. WARRANTY WILL BE VOIDED IF THESE PROCEDURES HAVE NOT BEEN FOLLOWED.
