IMPORTANT NOTICE

IMPROPER INFLATION EXAMPLES

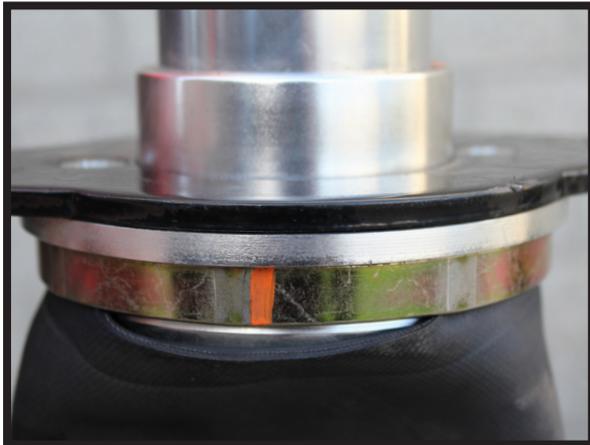
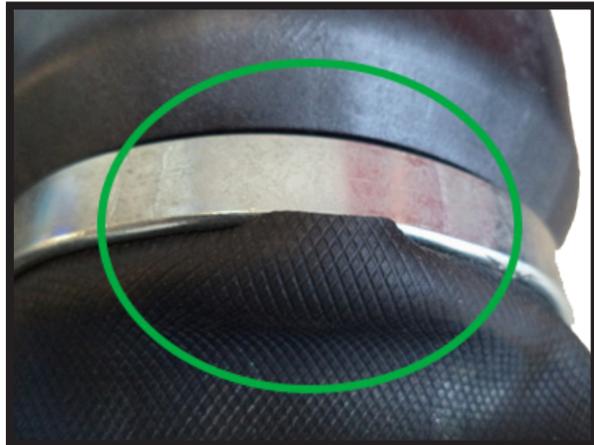
Air springs inflated without following the manufacturer's specifications/not supporting the vehicle weight can cause the force to distribute unevenly, which may result in crimp ring failure.

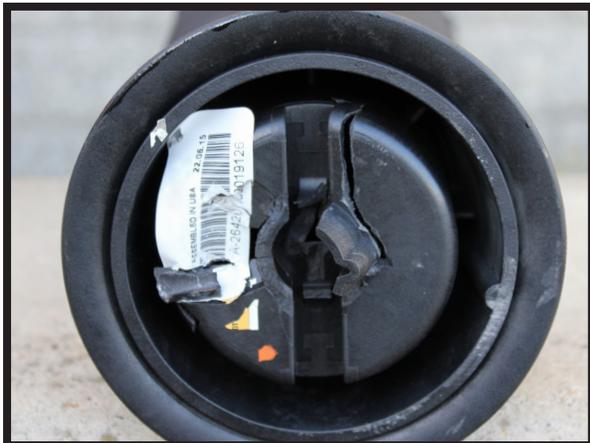
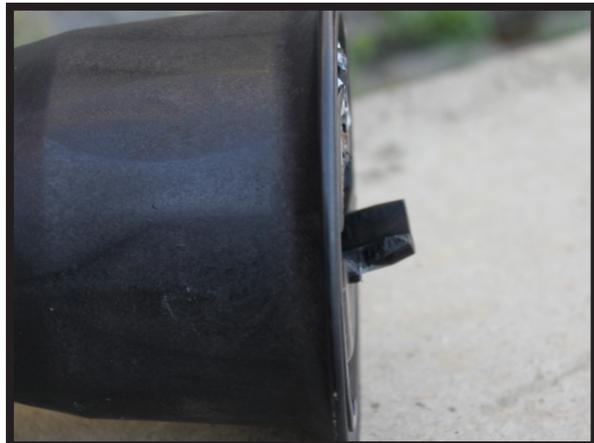
TOP AND BOTTOM MOUNTS OF THE AIR SPRING ARE BROKEN

The top and/or bottom mounts may break if the air spring is not seated properly, or if the correct inflation procedures are not followed.
