HP1648 - CONNECTING THE PRESSURE FEED PIPE

STEC.10029 18/07/22

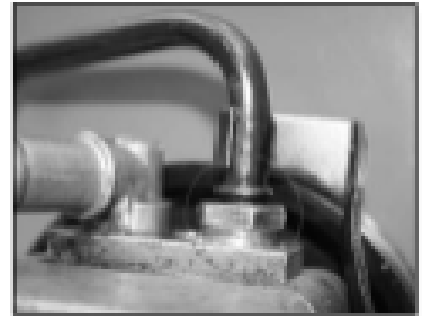
Figure 1

Care is needed when connecting the pressure feed pipe (figure 1). It is important not to over tighten the fitting as this will strip the thread. Please be aware that, even after the fitting is fully secured, the feed pipe can still be moved. This is quite normal for this design.

Damage to the pressure port thread caused by over tightening will invalidate the warranty.

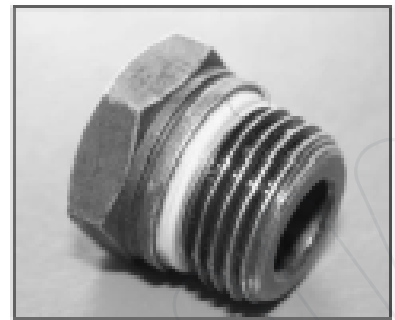
Figure 2

A nylon washer is fitted to the thread of the pressure port fitting (figure 2). We recommend that this is replaced with a new washer each time the fitting is removed. The washer makes a fluid seal on the thread of the fitting. If it is damaged it is likely that the fitting will leak.

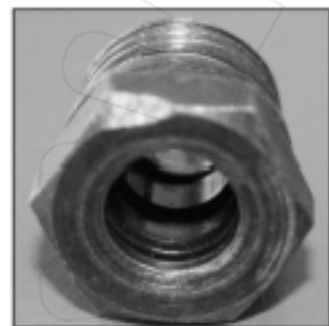
Figure 3

The pressure port fitting has an internal O ring (figure 3). It is important that this is checked following installation to ensure it is not damaged. If the fitting is leaking, it will need to be replaced or a new pipe assembly fitted.

NB: It is important that any fluid leak from the pressure port fitting is corrected immediately. Fluid from the fitting can contaminate belts that run in the area around the steering pump.
