HP1648 - CONNECTING THE PRESSURE FEED PIPE

STEC.10029 18/07/22

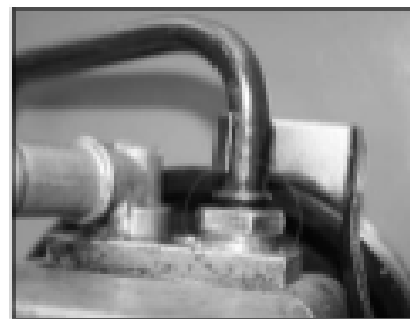
Figure 1

Care is needed when connecting the pressure feed pipe. It is important not to over tighten the fitting as this will strip the thread. Please be aware that, even after the fitting is fully secured, the feed pipe can still be moved. This is quite normal for this design.

Damage to the pressure port thread caused by over tightening will invalidate the warranty.

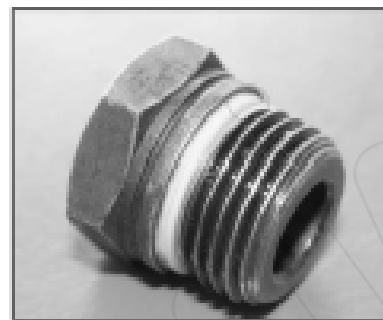
Figure 2

A one use union is used and must be replaced when changing the pump. We recommend that this is replaced each time the fitting is removed. The union makes a fluid seal on the thread of the fitting. If it is damaged it is likely that the fitting will leak.

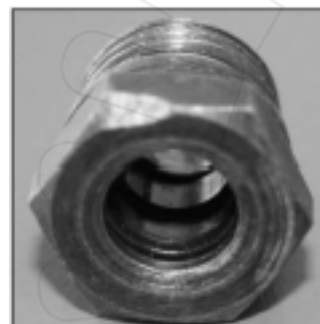
Figure 3

The pressure port fitting has an internal O ring. It is important that this is checked following installation to ensure it is not damaged. If the fitting is leaking, it will need to be replaced or a new pipe assembly fitted.

NB: It is important that any fluid leak from the pressure port fitting is corrected immediately. Fluid from the fitting can contaminate belts that run in the area around the steering pump.
