AUTOMOTIVE – PASSENGER CAR

LOOSENING THE WATER PUMP BEFORE BELT INSTALLATION IS VITAL TO CORRECT TENSION ON HOLDEN & DAEWOO 16V PETROL ENGINES

BULLETIN: TSB003_AU

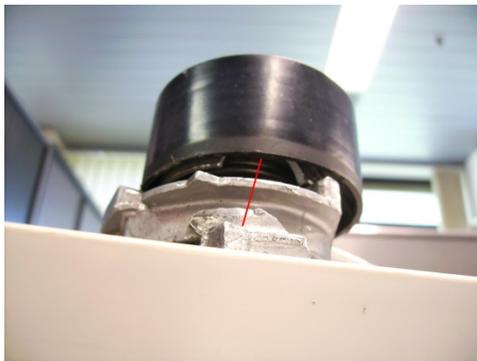
Fig. 2

Also, leaving the old tensioner on without loosening the tensioner bolt is not the correct procedure to follow.

If the tensioner bolt is not loosened, the pointer of the tensioner will hit the cold stop violently. This could seriously damage the pointer, resulting in a rupture (later on). Proceeding this way, in order to be able to install the new belt, the pointer of the tensioner has to be pushed back. When trying this with a screwdriver, you risk that the screwdriver will slip off the pointer (because of the high spring tension) which will again hit the cold stop. Fig. 3 shows where the pointer is situated on a good tensioner (in its rest position).

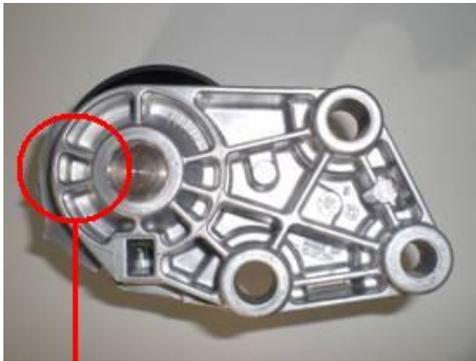
Fig. 10

In addition, watch out for counterfeit tensioners which can be widespread in certain markets (Fig.10 and 11 are OE, Fig. 12 is counterfeit).
