TECH NOTE

BULLETIN: TSB_027_AU

FOLLOWING THE OEM INSTALLATION PROCEDURE CORRECTLY IS CRITICAL ON 4D56 DOHC ENGINES

- 2.5L Diesel (4D56 DOHC)
-

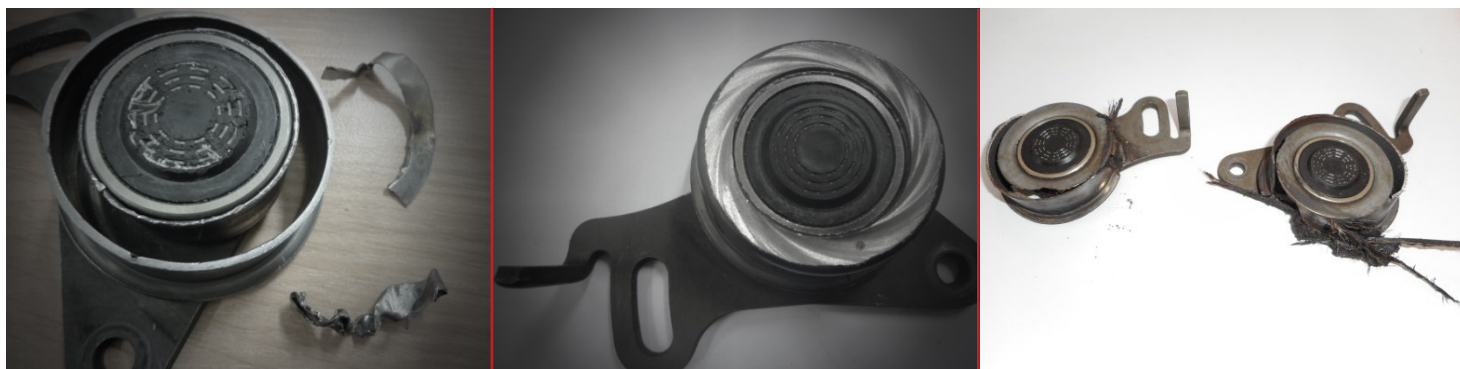
- Camshaft assembly bolt braking.
- Balance shaft tensioner failure.
- Timing belt jumping teeth.
- Balance shaft belt shredding and interfering with the camshaft belt.

Images of failed balance shaft tensioner pulleys due to incorrect installation:
