# AUTOELECTRO

## STARTER MOTORS & ALTERNATORS

**IMPORTANT PLEASE READ THE INFORMATION BELOW BEFORE FITTING THIS PART AS THERE ARE KNOWN ISSUES WHICH WILL RESULT IN THE PREMATURE FAILURE OF THE UNIT AND MAY INVALIDATE YOUR WARRANTY**

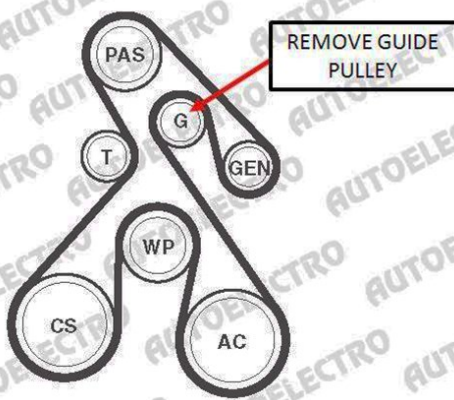
ORIGINAL BELT ROUTING

The vehicle to which this alternator is fitted has a known fault which results in the premature failure of the clutch pulley and/or bearings. The premature failure can be caused due to excessive load being exerted to the alternator pulley and bearings.

It is recommended that the belt is replaced with a **7PK1785** and a guide pulley is removed. By carrying out this modification the pressure applied to the components is reduced.
