CITROËN / PEUGEOT **REAR BRAKE DISC INSTALLATION**

Issue Date: 03/2019 Issue Number: BRTB0004B

APPLICATION: Citroën C4, C4 Grand Picasso, DS4, DS5, Peugeot 308, 3008, Berlingo, Partner

APPLICABLE REFERENCES: BBD5841S, BBD5842S

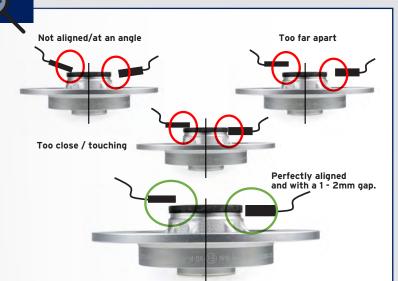
If once a new disc has been installed you can see that the ABS Sensor is contacting the magnetic reader, or the gap is not aligned correctly, then the disc and ABS Sensor should be removed, taking care not to damage the ABS Sensor. Once removed, clean the rust and corrosion from the ABS Sensor seating location. When sufficiently cleaned and correctly seated, with the disc re-installed, you will be able to see a clear 1-2mm gap.

Below you can see two examples of ABS Sensors located in different positions, however the principle remains the same.

To avoid damage to the magnetic encoder, keep it away from magnetic fields. The plastic cap protecting the seal should only be removed just before fitment.
