Stem fractures on intake and exhaust valves

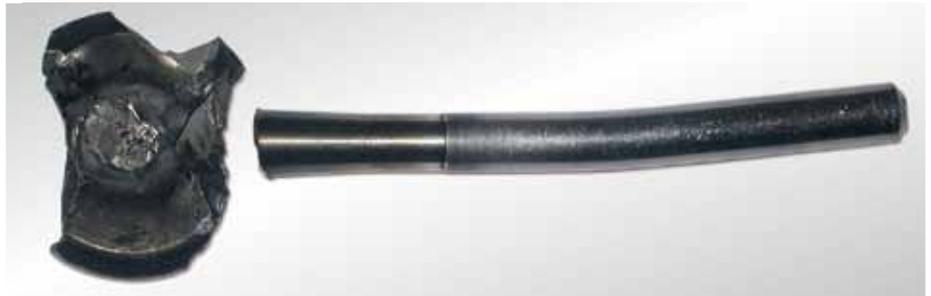
Fig. 1

cylinder head repair (the toothed belt had broken). A short time after the vehicle was on the road again, there was another damage of the valve train. On dismantling the engine, a valve was discovered that was broken on its valve stem end and valve head. An examination of the parts showed that the valve stem end has been broken first, namely in the area of the lower recess for the valve cotter. During further course of the damage, the valve fell into the combustion chamber where it collided with the piston and has been destroyed.
