CAMSHAFT ADJUSTER PTA126-0001

TECHNICAL INFORMATION FOR INSTALLATION

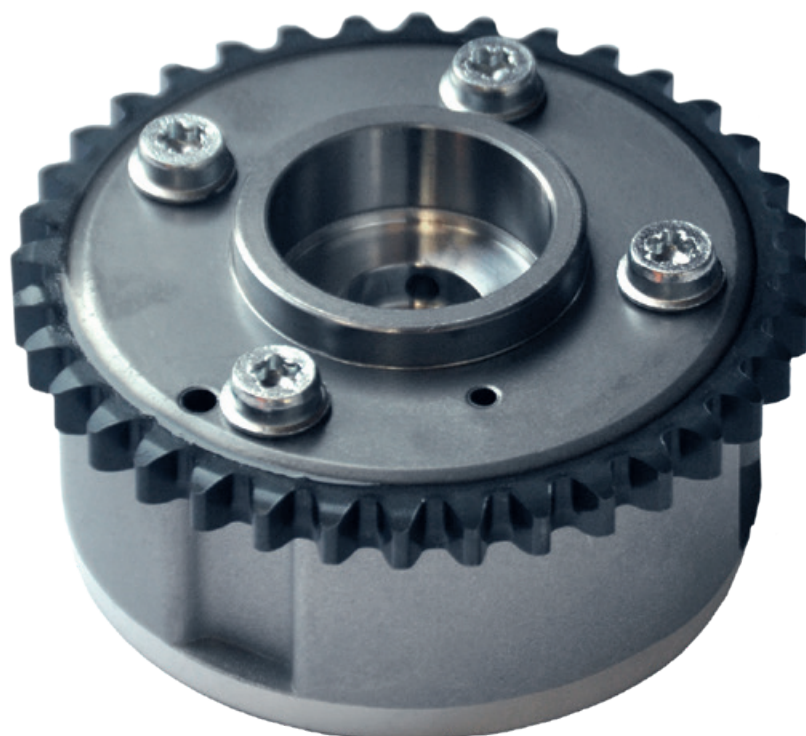
For the dedicated cars it can happen that after assembly of a new camshaft adjuster and at the cold starting phase of the engine „rattling“ noises occur during start-up of the car in the environment of the engine.

A reason could be that the related oil control valve is polluted and was not replaced or that the oil control valve after assembly of the new camshaft adjuster was not readapted to the electronic control unit (ECU). But it is essential for a correct function of the new camshaft adjuster.

It could lead then to a so called „chain rattling“, which causes without fail an early wear (elongation!) of the timing chain as well as of the sprockets and of the chain tensioner.

In the worst case an engine damage can be arisen!

The car manufacturer instructs that the camshaft adjuster for the timing chain kits PTA114-0021, -0231 und -0232 has also to be replaced!

Furthermore it is recommendable that the electronic control unit (ECU) receives an update of the software after assembly of the camshaft adjuster.
