EGR MODULE PTA510-0260

TECHNICAL INFORMATION

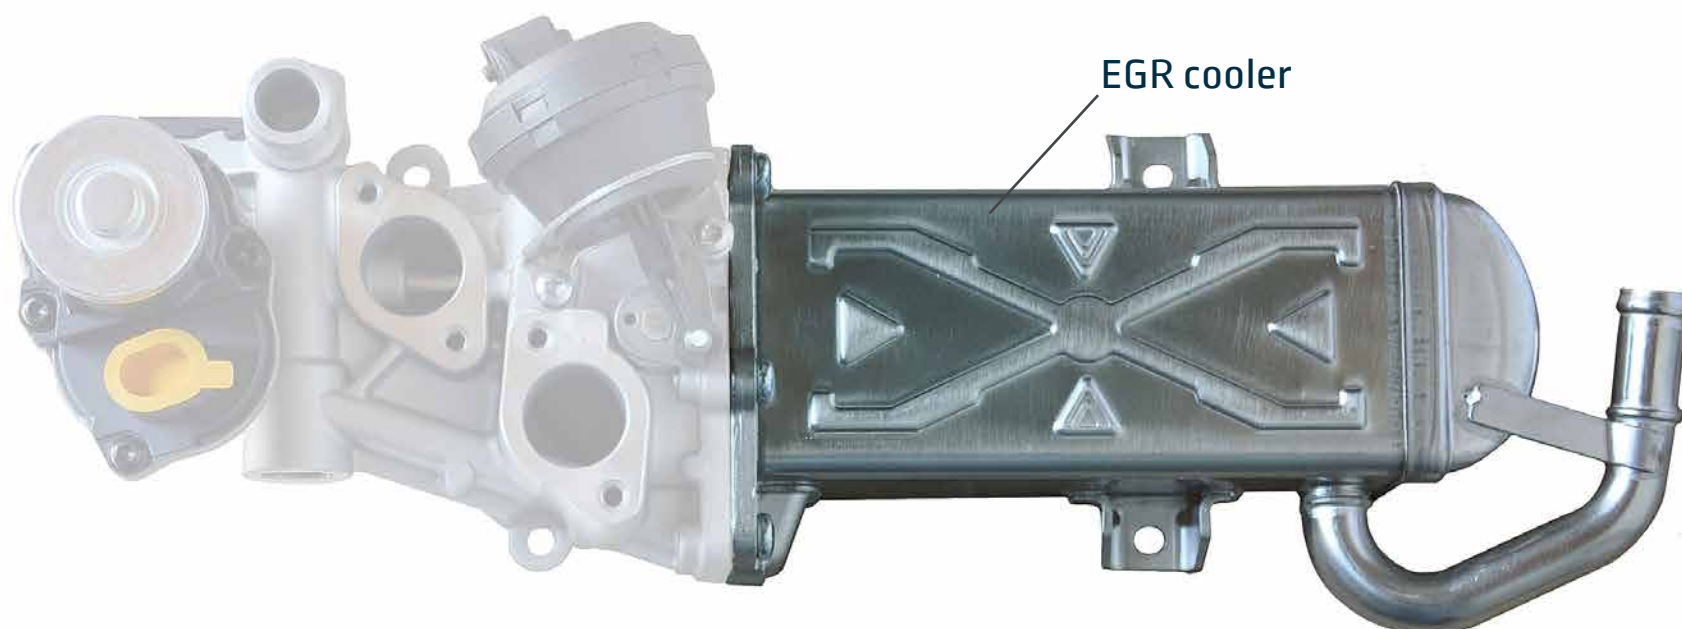
The function of the additional water pump [OE No.: 5N0 965 561] for the coolant circulation may be restricted by a contact resistance in the electrical wiring harness without an entry being stored in the fault memory. In some cases, the EGR error code P0403 may be displayed although the EGR module is functional. This error code can indicate a defective additional water pump.

A defect of this can result in overheating and thus an internal or external leak at the EGR cooler of the EGR module.

1. Use the „Guided search for faults or actuator diagnosis“ to control and check the additional water pump for coolant circulation.
2. Check the electrical, three-pin plug connection of the additional water pump for damage and correct position of the pins. If necessary, repair the plug connection according to the vehicle manufacturer.
3. Check EGR cooler of EGR module for leaks. If leakage occurs, replace EGR module.

If fault code P0403 occurs, a check of the additional water pump (OE no.: 5N0 965 561) or the actuator diagnosis must be documented.
