High pressure pump PTA441-0001

TECHNICAL INFORMATION ON INSTALLATION

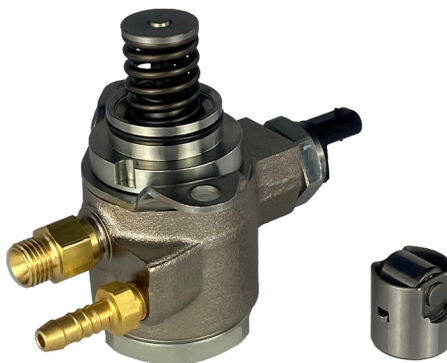
PTA120-0043

A run-in or worn roller tappet (OE no.: 06L 109 311) of the high-pressure pump can cause, among other things

1. noises,
2. uneven engine running and
3. error messages [e.g. P0087; P2293]

although the high-pressure pump is fully functional.

PartsTec specifies the replacement of the roller tappet, PTA120-0043, when replacing the high-pressure pump.

The roller tappet must always be checked for wear during the repair. There is no additional work.
