TECHNICAL BULLETIN

TB-NFO-01 V1

OIL PRESSURE ISSUES PSA 1.2 VTI ENGINES

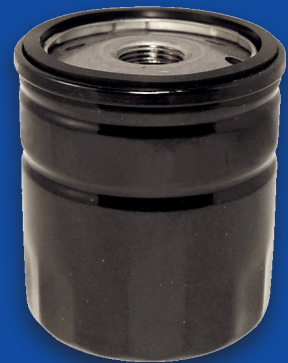
NF03011

Instances of the oil pressure warning light remaining on after an oil filter replacement have been documented on some 1.2 VTI PSA engines. This could lead to the assumption that the oil filter is not providing sufficient oil flow to the engine. Our technical review of the filter has found no issue with its function, but we have provided recommended actions to prevent this from occurring.
