TECHNICAL BULLETIN

NAL1118 - Mercedes A Class

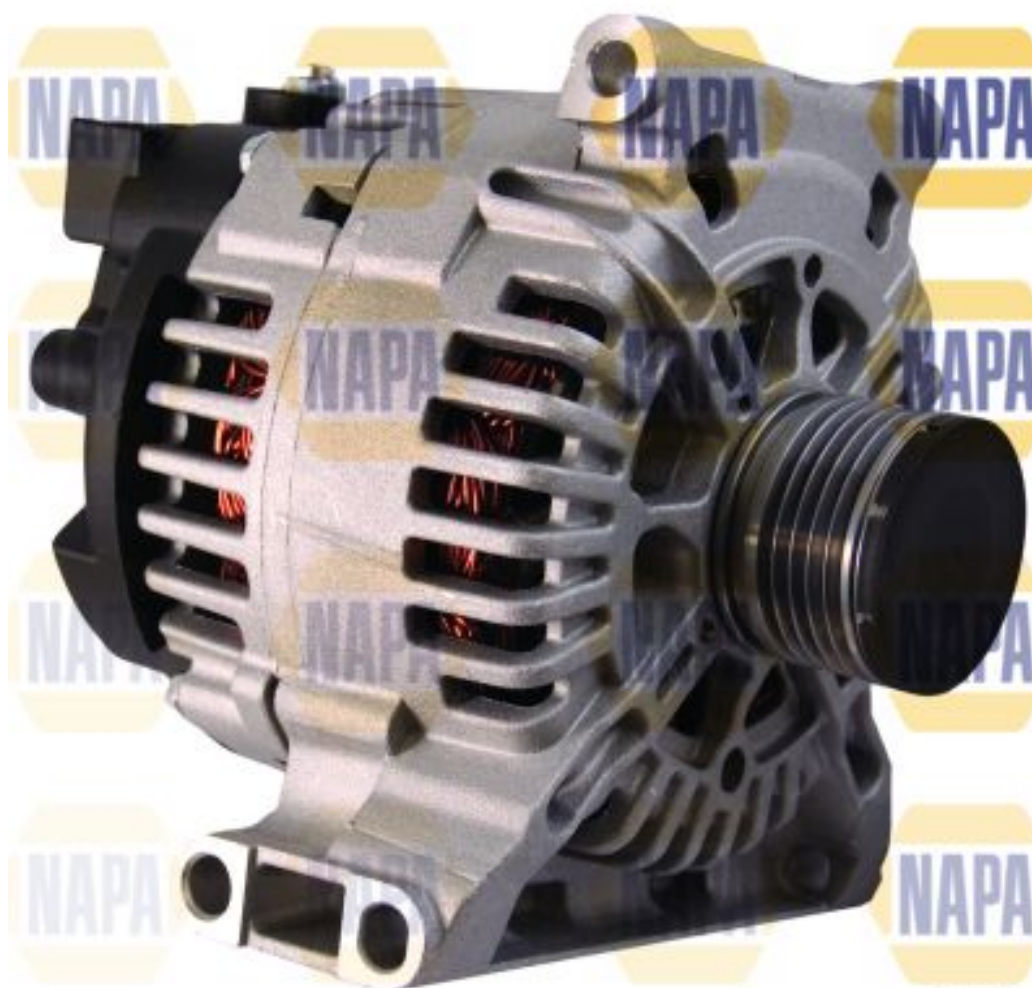
A charge issue on the Mercedes A Class CDi is often due to a fault with the engine ECU or the front 'SAM' control unit.

Both of these control units control and monitor the alternator charge output and should be checked before replacing the alternator
