TECHNICAL BULLETIN

NAL1118 - Mercedes A Class

Bulletin Ref: TB21n

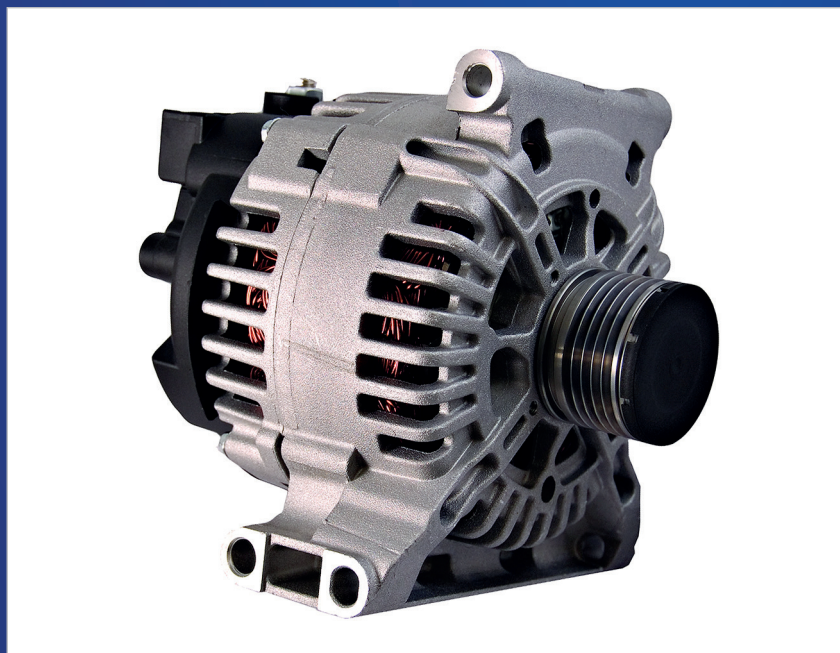
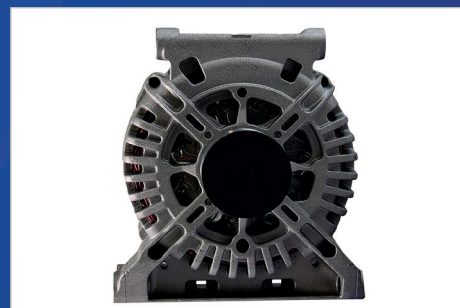
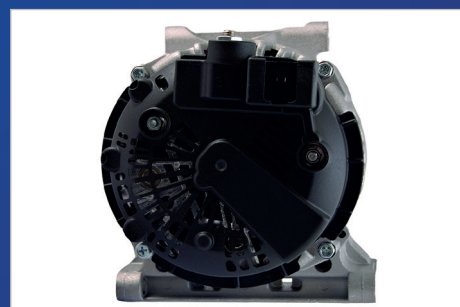
A charging issue on the Mercedes A Class CDi is often due to a fault with the ECU or 'SAM' control unit.

Both of these control units control and monitor the alternator charge output.
