## TECHNICAL BULLETIN

### NAL1121 - Ford Alternator Broken Wire

Bulletin Ref: TB19n

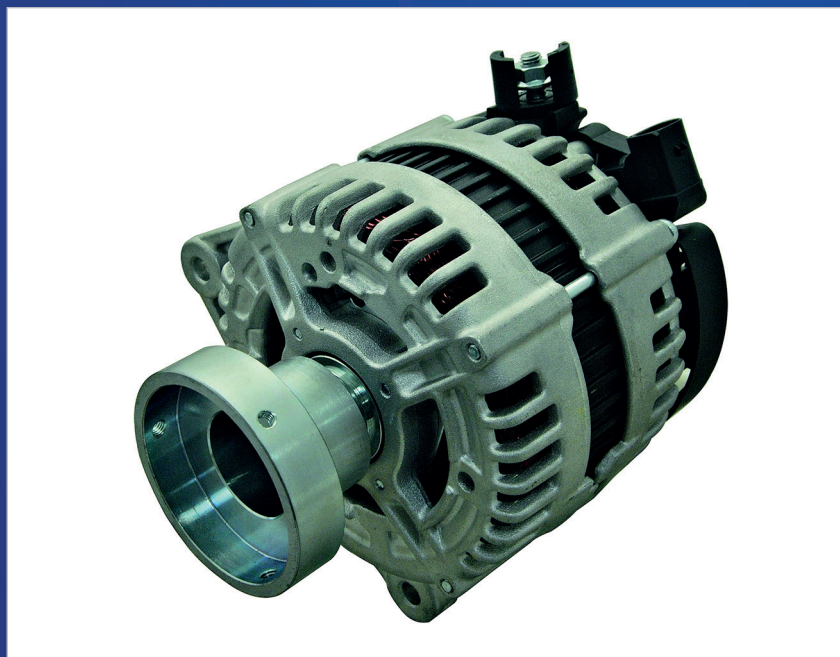
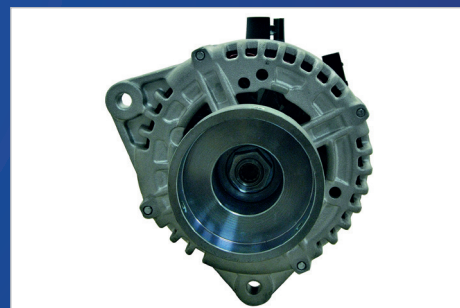
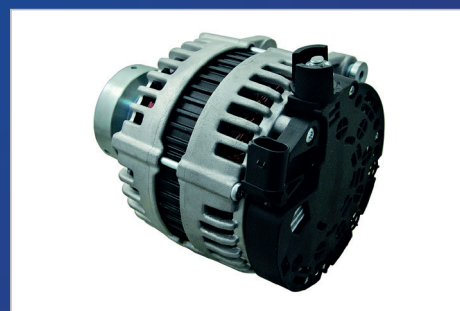
Possible issues relating to charging problems:

1. One Amp fuse is sometimes defective, this can be found in the main fuse box in the engine bay.
2. The wiring harness from factory is too tight resulting in broken wires in the harness, the wires are mostly broken under headlight.
3. Corrosion inside the multi connector on the rear of the unit is also common.
