## TECHNICAL BULLETIN

### NAL1139 - Ford Broken Wire

Bulletin Ref: TB19n

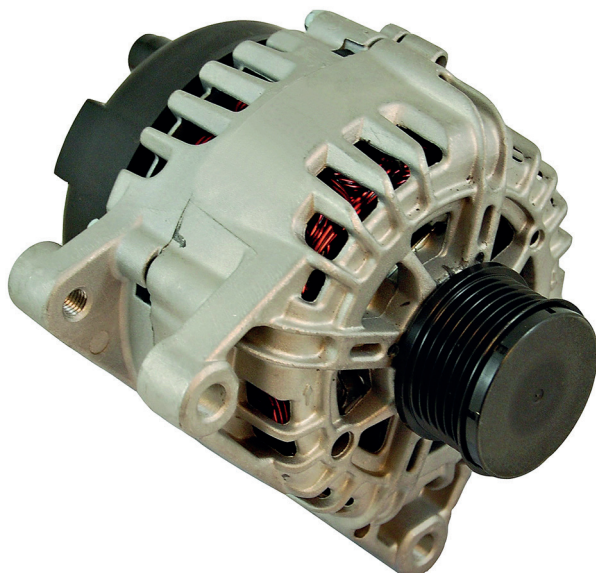
Possible issues relating to charging problems:

1. One Amp fuse is sometimes defective, this can be found in the main fuse box in the engine bay
2. The wiring harness from factory is too tight resulting in broken wires in the harness, the wires are mostly broken under headlight
3. Corrosion inside the multi connector on the rear of the unit is also common.
