TECHNICAL BULLETIN

NAL1146 - Ford Broken Wire

Bulletin Ref: TB19n

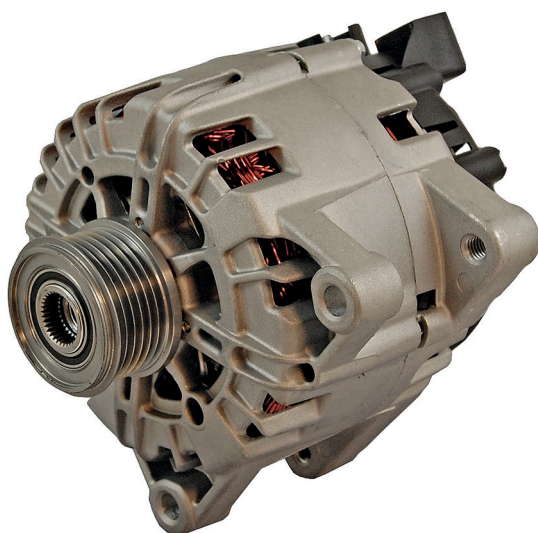
Possible issues relating to charging problems:

1. One Amp fuse is sometimes defective, this can be found in the main fuse box in the engine bay
2. The wiring harness from factory is too tight resulting in broken wires in the harness, the wires are mostly broken under headlight
3. Corrosion inside the multi connector on the rear of the unit is also common.
