TECHNICAL BULLETIN

NAL1373 - Ford Broken Wire

Bulletin Ref: TB19n

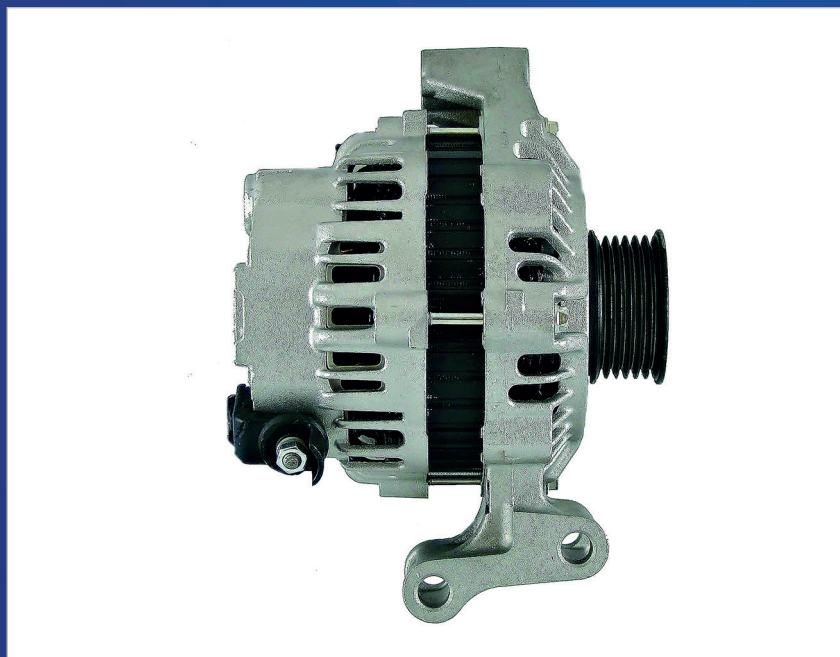
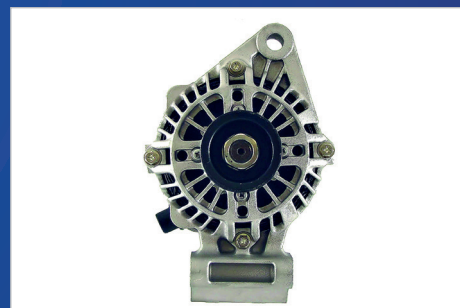
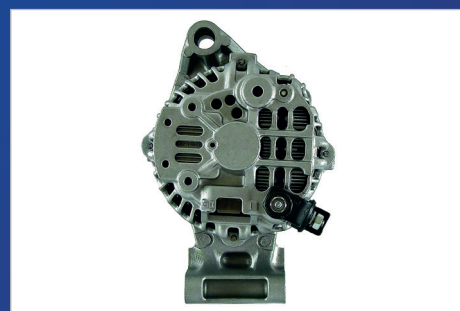
Possible issues relating to charging problems:

1. One Amp fuse is sometimes defective, this can be found in the main fuse box in the engine bay
2. The wiring harness from factory is too tight resulting in broken wires in the harness, the wires are mostly broken under headlight
3. Corrosion inside the multi connector on the rear of the unit is also common.
