TECHNICAL BULLETIN

NAL1404 - Ford Broken Wire

Bulletin Ref: TB19n

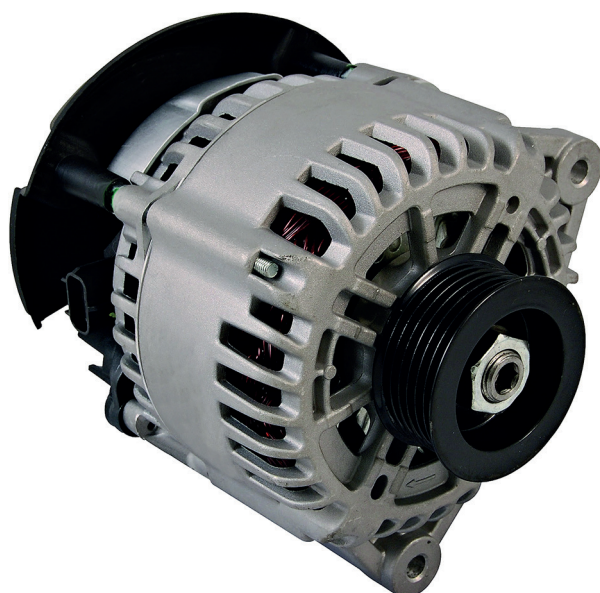
Possible issues relating to charging problems:

1. One Amp fuse is sometimes defective, this can be found in the main fuse box in the engine bay
2. The wiring harness from factory is too tight resulting in broken wires in the harness, the wires are mostly broken under headlight
3. Corrosion inside the multi connector on the rear of the unit is also common.
