## TECHNICAL BULLETIN

### NAL1650 - 80amp Korean Fuse

Bulletin Ref: TB11n

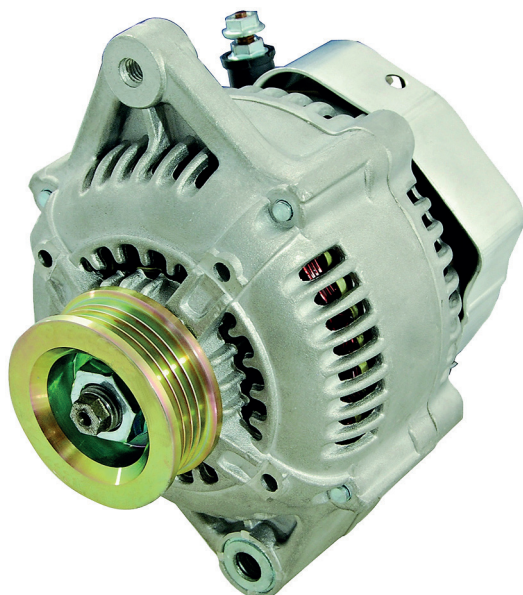
Fig 1.

Before fitting check the 80a PAL type fuse as this fuse can blow causing no charge. (Fig 1.)

Also check for corrosion around and underneath the fuse connections which is common.
