## TECHNICAL BULLETIN

**NAL1702**

**Bulletin Ref: TB5n**

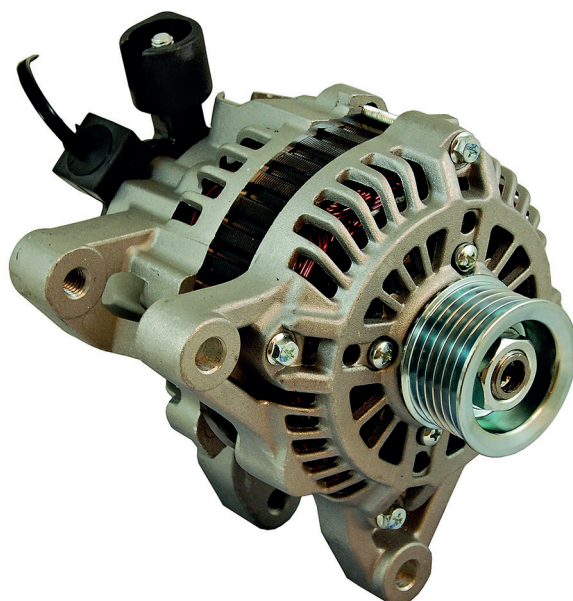
**Common issues for charging problems:**

- 1. This unit is controlled by the vehicles ECU which can be defective.**
- 2. A corroded B+ cable from alternator to the battery is also common issue.**
