NAL1712 - 80amp Korean Fuse

Bulletin Ref: TB11n

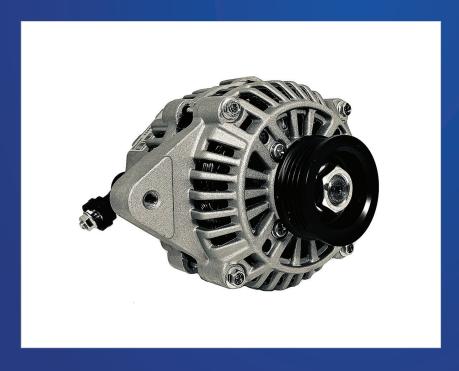
Before fitting check the 80a PAL type fuse as this fuse can blow causing no charge. (Fig 1.)

Also check for corrosion around and underneath the fuse connections which is common.
