TECHNICAL BULLETIN

NAL1747

Bulletin Ref: TB4n

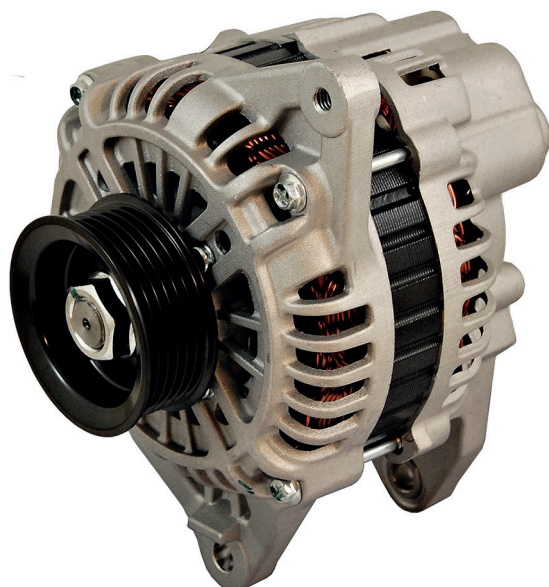
Poor or corroded connections on the rear of the alternator are common creating charging issues, this can also cause the charging light to illuminate when the unit is still charging.

Please double check before ordering and fitting.
