KNOW HOW TECHNICAL BULLETIN

NAL1884 - Honda Civic

Bulletin Ref: TB17n

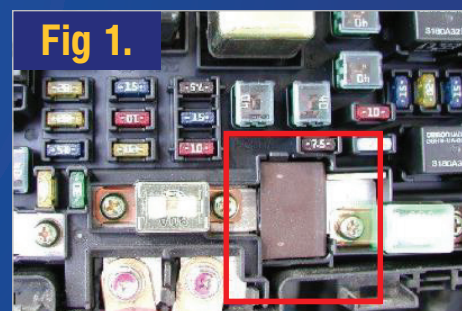
This model of Honda Civic is fitted with a variable output alternator which relies on a battery sensor and an ELD (electrical load detector) if either one of these relatively low cost components is defective a no charge warning will appear on the dashboard.

The ELD module is a very common failure, it sits in the engine bay fuse relay box. (Fig 1.)

In some cases a software update is required to overcome charging issues, please check with a Honda dealer that the vehicle has received the latest update.

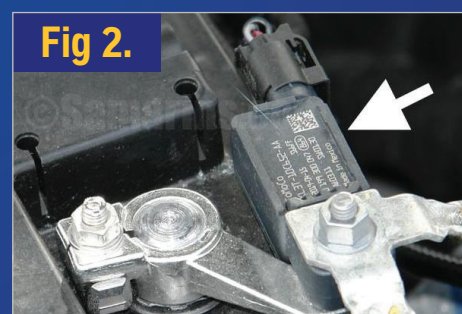
The battery sensor is built into the negative battery cable connector. (Fig 2.)
