TECHNICAL BULLETIN

NSM1024

Bulletin Ref: TB27n

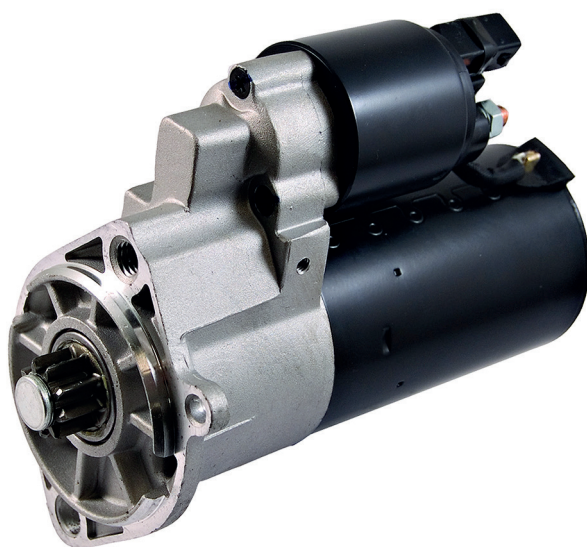
The ignition switch can be defective causing the starter motor to either keep running resulting in the starter motor burning out prematurely or to not turn at all.

Please double check before ordering and fitting.
