NSM1265

Bulletin Ref: TB27n

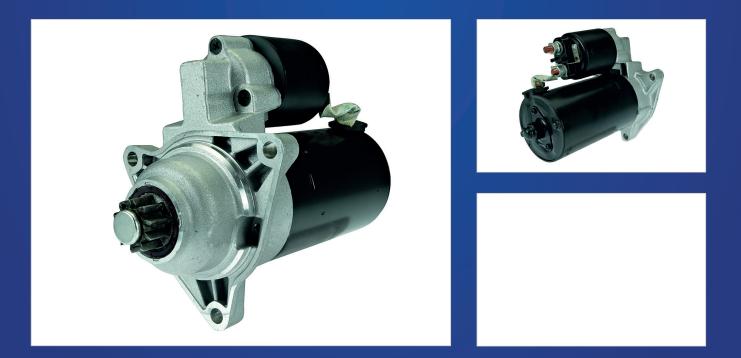
The ignition switch can be defective causing the starter motor to either keep running resulting in the starter motor burning out prematurely or to not turn at all.

Please double check before ordering and fitting.
