## TECHNICAL BULLETIN

### NSM1722

Bulletin Ref: TB20n

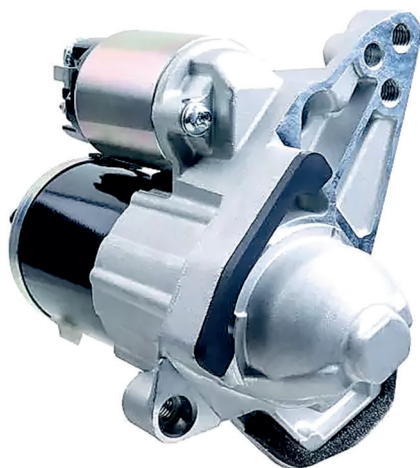
This vehicle is prone to the ignition start button failing, remaining in the start position causing the starter motor to continually run, this will result in the starter motor premature burning out and also a risk of fire due to overheating. Please double check the switch before ordering and fitting.
