**NEW: Gasket, cylinder-head for Engine Repair**

# MAN D2066 LF | LOH | LUH

**195.470 |

1.5 mm**

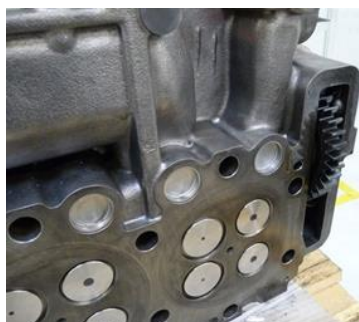
**Cylinder-head sealing surface with spur gear**

gears in the cylinder-head and the engine block (see images) make it necessary for the material removed as a result of the mechanical working of the sealing surfaces to be compensated by means of a correspondingly thicker cylinder-head gasket.

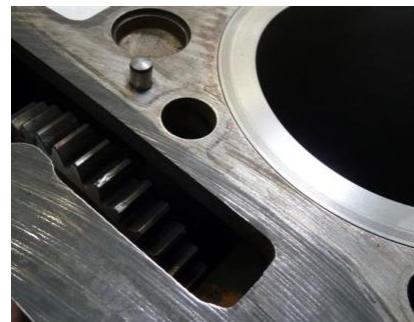
**Engine block sealing surfaces with spur gear**

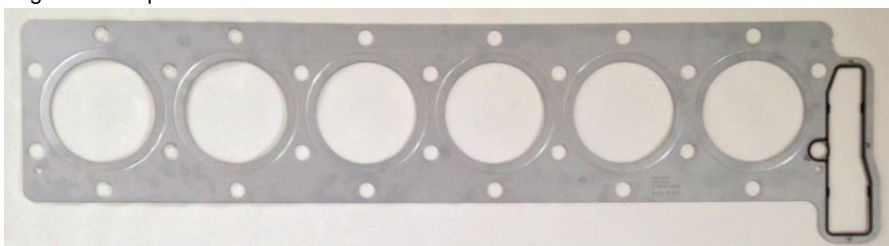
As can be seen in the image, in contrast to the standard gasket it has an additional notch at the front that is also clearly visible when it is installed.

**Important: It is extremely important to check the engine components that are affected by this modification (e.g. injection nozzle as a result of an excessive protrusion).**
