## SERVICE ENGINEERING BULLETIN SB2125.1

# Valve head cracking / breaking

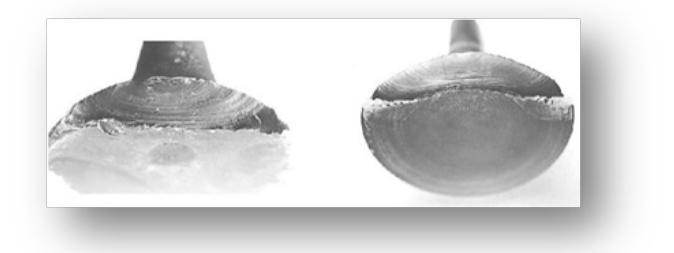
#### **1.Valve Headchordal Failure**

This is the most typical form of valve head failure. The valve head breaks through a chord line, i.e. a failure stretching across two points on the circular edge of the valve head. This usually produces considerable secondary damage to the piston, cylinder head and sometimes the cylinder bore.

This is a fatigue type failure, the causes of which are:

- The valve head's inability to stand up to the stresses from the gas loading.
- The valve head temperature effect on the ultimate tensile strength of the valve material.

The initiation point is usually about halfway up the underhead radius. This does vary to some extent according to the section design of the valve head. This is a problem mainly confined to the engine manufacturer during the development of a new or uprated product but it can occur in service. Although the term chordal is applied, there may be many variations on the shape of the developing crack. This sometimes travels a considerable way round the underhead radius before propagating out to the valve seat. Fundamentally, the skin of the underhead radius at some point being too highly stressed causes such valve head failures. In service the reasons for this could be:

a. Excessive load on the engine coupled with over-fuelling or other maladjustment, resulting in excessive valve temperature and gas pressures.

b. Poor finish on the underhead radius on highly stressed valves. Note, some valves are shot peened or spiral-polished to increase resistance to skin fatigue.

c. Damage marks on the underhead radius.

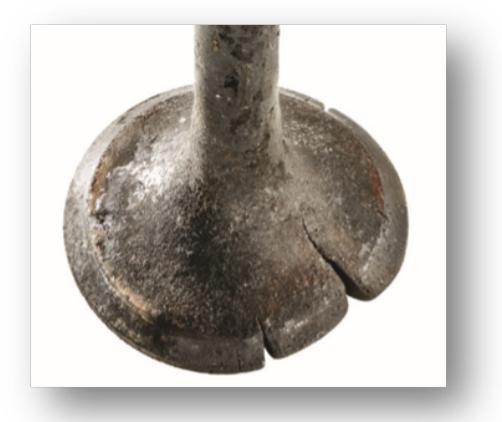
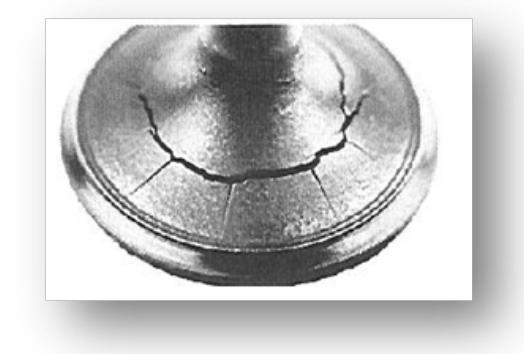
#### 4. Burn Through On Rear of Valve Face

On occasions, a hole burns through the exhaust valve head at the back of the seating face that leaves the seating face virtually unmarked. Close examination, however, shows the start of the failure is a rim crack. With rapid erosion of the valve head material, combustion gases can escape through the crack. This is also another example of radial rim cracking or, thermal fatigue.
