CLUTCH TECHNICAL GUIDE

TBC92

Misalignment Explained

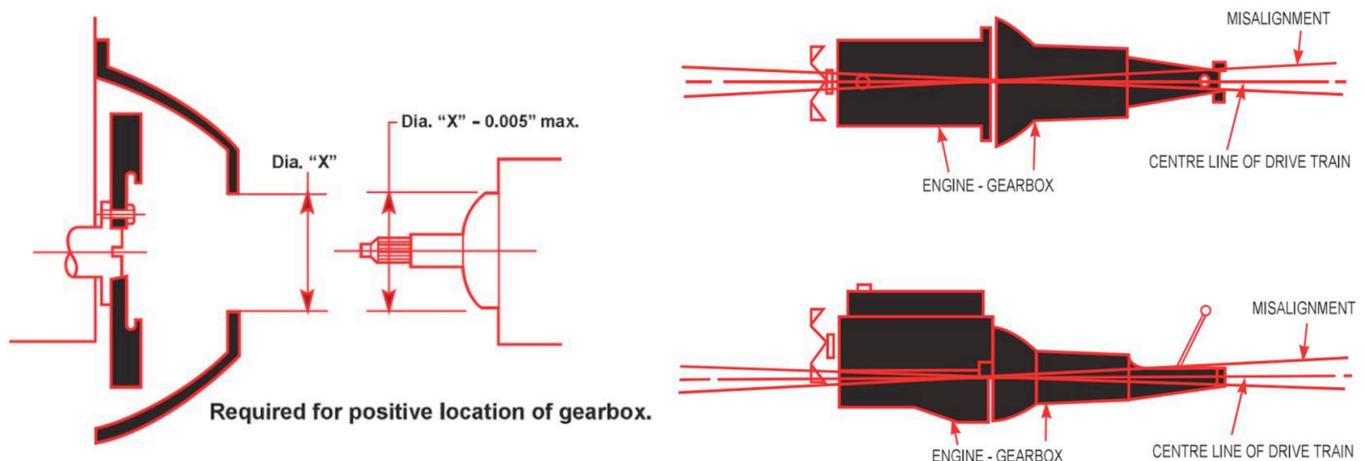
Does the old clutch you removed show any of these signs of wear?

- Broken clutch plate
- Worn diaphragm fingers
- Red dust covering the clutch components
- Loose pivot rings inside the cover assembly
- Burrs on the clutch plate hub
- The release bearing guide has worn on one side

If it does, the clutch has probably failed due to driveline misalignment.

Fitting a new clutch without rectifying any misalignment issues will lead to possible premature failure of the new clutch you're about to install.
