CLUTCH TECHNICAL GUIDE

TBC92

Misalignment Explained

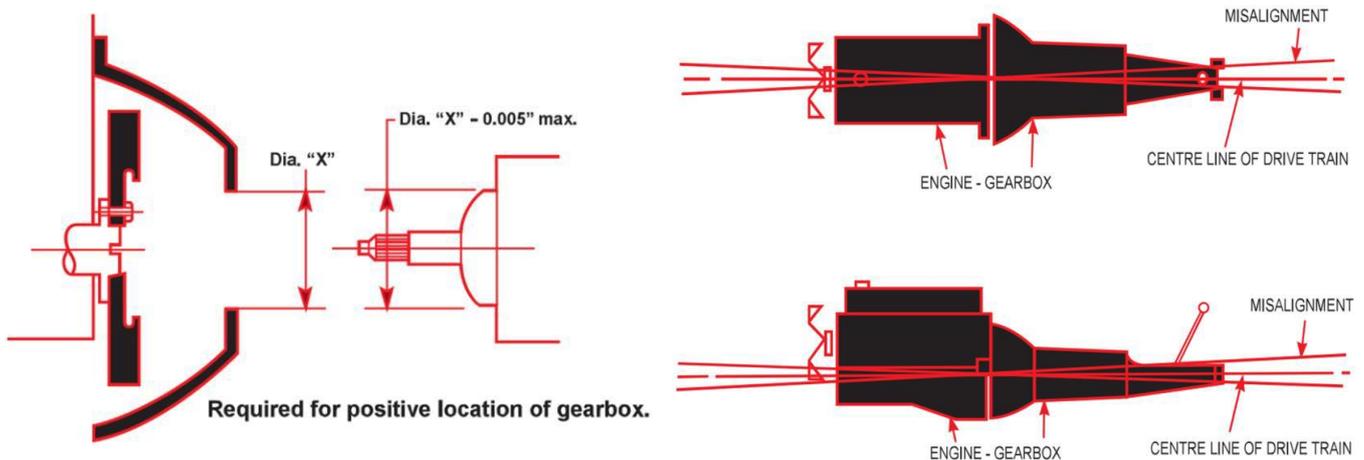
Does the old clutch you removed show any of these signs of wear?

- Broken clutch plate
- Worn diaphragm fingers
- Red dust covering the clutch components
- Loose pivot rings inside the cover assembly
- Burrs on the clutch plate hub
- The release bearing guide has worn on one side

If it does, the clutch has probably failed due to driveline misalignment.

Fitting a new clutch without rectifying any misalignment issues will lead to possible premature failure of the new clutch you're about to install.

Whenever you are replacing a clutch, inspect the old components. If misalignment is present, you will need to determine the cause and rectify it so that it doesn't occur again.

- Inspect all dowels and dowel holes for condition.
- Inspect the release bearing guide and replace it if necessary.
- Clean all mating surfaces.
- Inspect block flange for damage.
- During reinstallation, ensure the clutch plate is aligned with pilot/spigot bearing.
- Ensure that the gearbox input shaft is aligned with the clutch hub, and that the gearbox is guided into position correctly.
