RepDPF

Repair set, pressure line

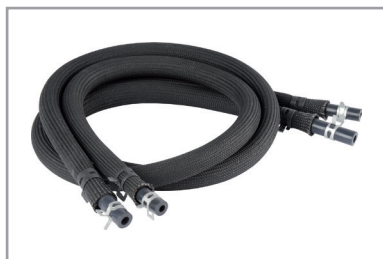
The problem: the line between the diesel particle filter and the differential pressure sensor is faulty

A faulty line between the diesel particle filter and differential pressure sensor means that the pressure value can no longer be measured correctly and that the particle filter no longer functions properly.

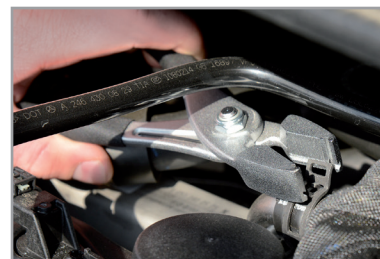
The solution: RepDPF – replace connection hoses quickly

It doesn't matter which cause is responsible, the RepDPF repair solution will help you remedy the problem quickly. The special, high-temperature-resistant protective hoses guard the silicone pressure lines against the aforementioned influences and are a long-lasting and effective countermeasure. The braided sheathing of the metre-long protective hoses in particular reliably defends the pressure hoses against bites from pine martens, even in the long run. This is accompanied by the fact that the pressure lines and protective hoses themselves have been made with high flexibility in mind; they can be bent to suit the respective damage scenario. Furthermore, they can be used universally for any vehicle, as the hoses can be easily shortened as required. The enclosed spring band clamps provide professional attachment.
