# febi EXAKT

Fits all engines with freewheeling alternator pulley.

## >> PROBLEM:

The belt tensioner for multi-v belt is faulty or broken.

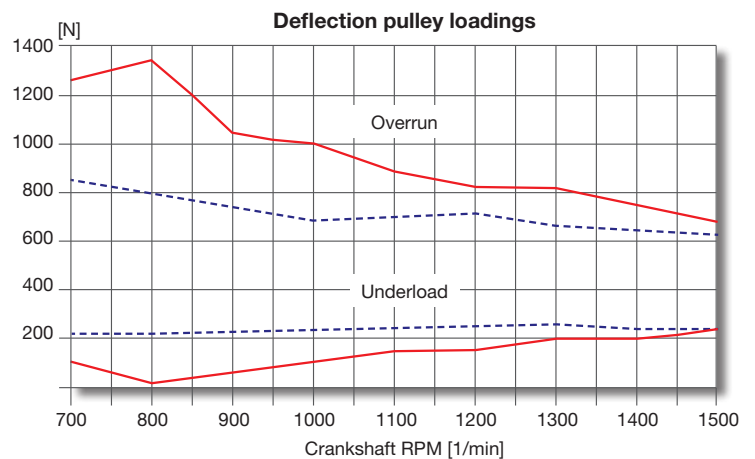
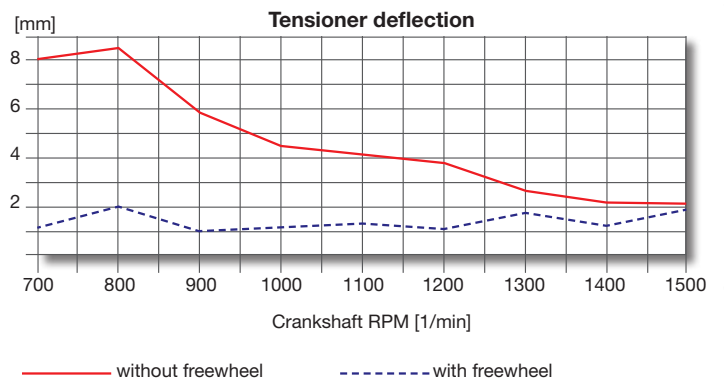
Freewheeling alternator pulley - measurements on Daimler 4-cylinder CR diesel engine

The freewheel located in the belt drive compensates the engine's vibrations. These vibrations can no longer be compensated if the freewheeling alternator pulley seizes. Consequently, it is not possible to achieve smooth belt travel particularly when idling or up to approx. 1400 rpm. The belt tensioner of the multi-v belt is exposed to above-average stress now that the belt begins to chatter. After a very short time or low mileage, the seized freewheeling alternator pulley causes premature failure of the belt tensioner and also of the multi-v belt. Under adverse circumstances this can mean major engine damage.
