To fit:  
various Mercedes-Benz models

## Oil Filter Housing Cap with sealing ring

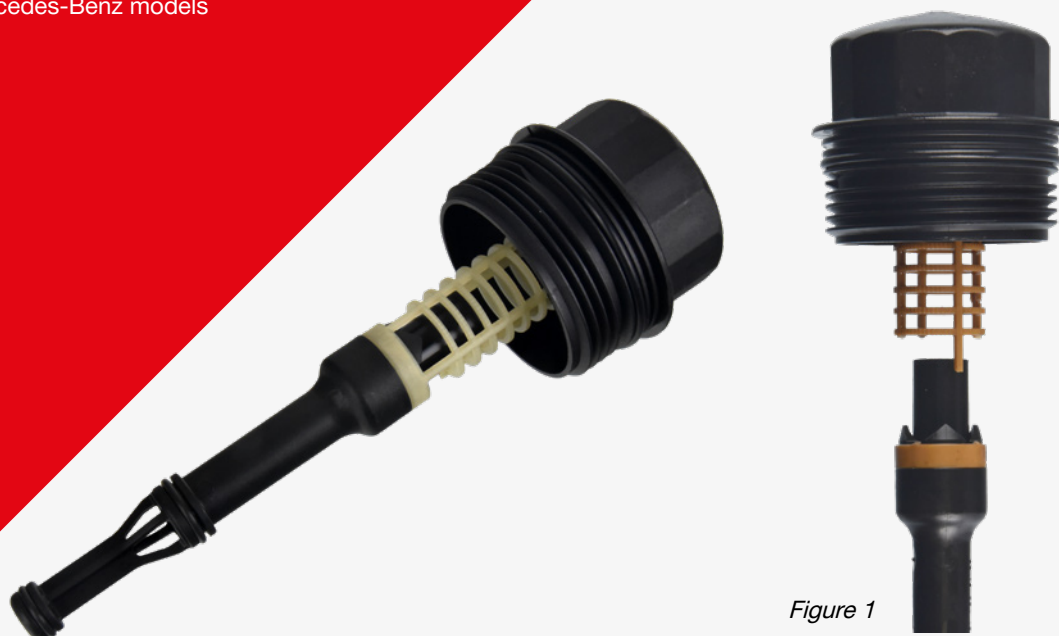
Figure 1

Whilst changing the engine oil filter during the service replacement process, the oil filter housing cap can break - leaving the oil filter alignment tube and element within the housing. (Fig.1)

After many hours of operation and continuous exposure to the engine oil heat cycles and vibration, the original oil filter housing cap alignment tube material becomes brittle and snaps.

Remove the oil filter element, and the remains of the oil filter housing cap alignment tube, from the housing. Check for any broken fragments and remove them, along with any excess oil. Replace the oil filter housing cap with febi part 173614 (which is supplied complete with all "O" ring seals), along with oil filter element 108276. Lubricate the seals with the engine oil and tighten the housing cap to the recommended torque of 25Nm.
