Blue Print ADG030148, ADG030149, ADB113012

To fit:
BMW MINI 1.4i, 1.6i and 1.4TD 2001 > 2008

Clutch kit

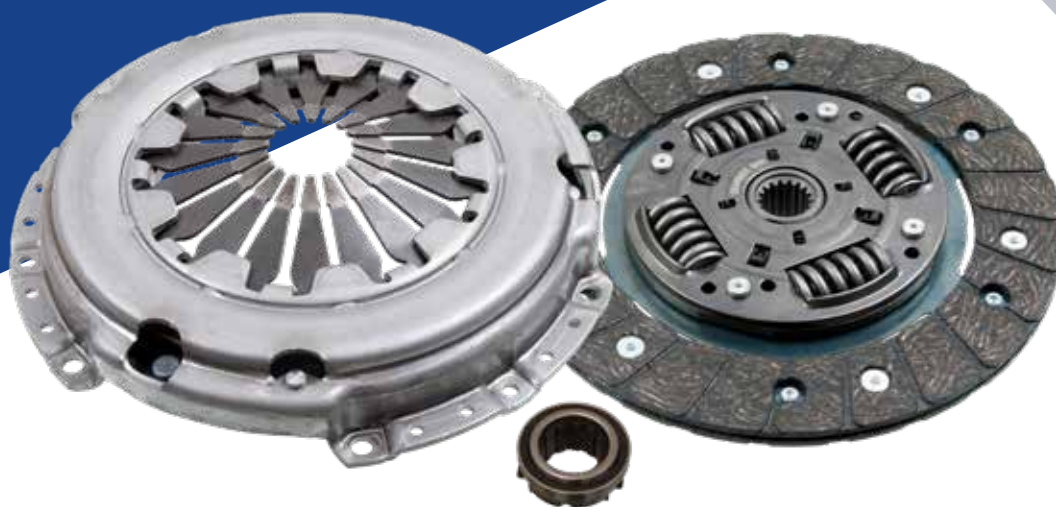
The vehicle exhibits symptoms such as the clutch not engaging, difficult gear selection and clutch 'judder'.

The welded area on the clutch fork can fracture. This allows the clutch fork to flex during operation, preventing the clutch from fully engaging. (Fig.1)

It is imperative that the clutch fork and the guide tube are cleaned and thoroughly inspected for fatigue or damage when the transmission is removed as part of a clutch replacement.

It is recommended that the clutch fork is replaced at the same time as the clutch, because the fork failure is a known issue with the MINI models listed above. Failure to identify and replace a faulty fork can cause clearance problems and difficulty in selecting gears. It is also recommended that the fork pivot bushes and locking pin are renewed at the same time.
