TSB-238

Colorado, Rodeo, Trooper, DMAX Transmission Removal & Installation

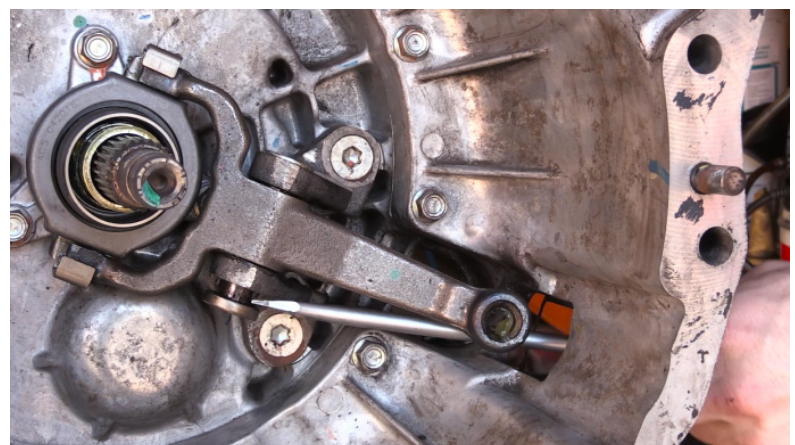
Place a pick inside the bellhousing and pull the R clip out from the top of the cross shaft.

With a flat head screwdriver, pry the cross shaft down so it drops into the bellhousing.

The transmission can then be removed from the engine. The clutch fork will drop off the transmission and separate from the bearing as the transmission is removed.

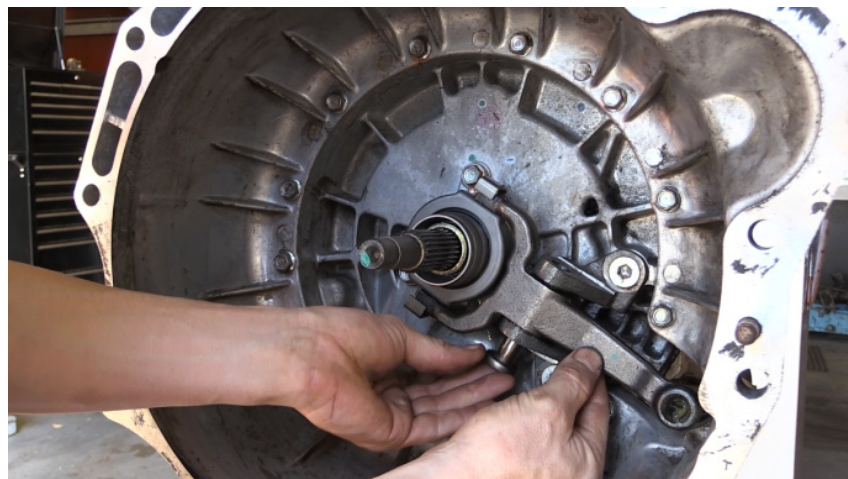
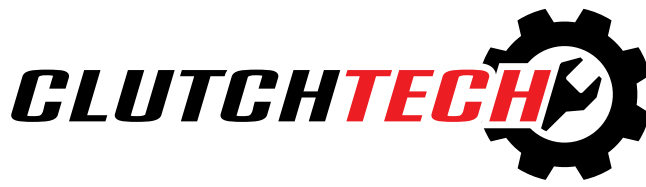
Slide the cross shaft in from the bottom. Re-install the washer and R-clip into the cross shaft and check for a smooth operation.

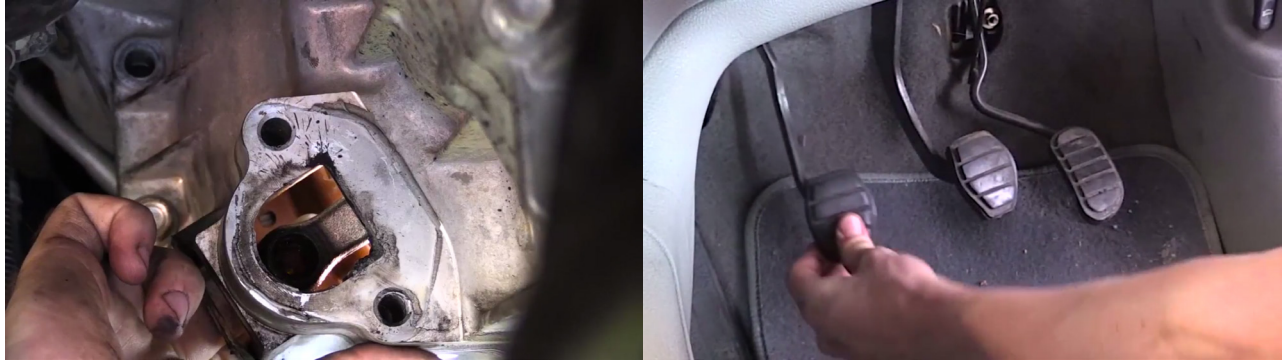
From outside the bellhousing, push the fork towards the back of the vehicle. The bearing should neatly clip into the diaphragm. Check that the bearing is clipped in securely by mounting the slave cylinder and operating the pedal. Check for full disengagement **before re-assembling the remainder of the vehicle.**

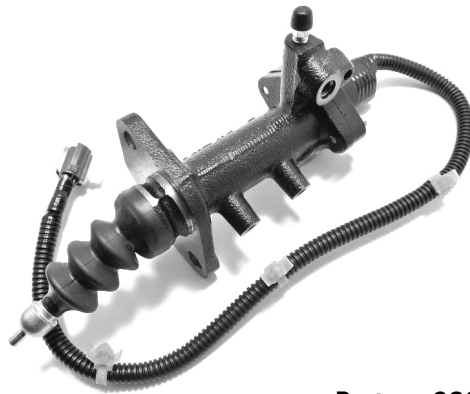
Part no: SCGM025

When replacing the clutch system in these vehicles it is important to inspect all other hydraulic components in the system as routine maintenance. The clutch slave cylinder can fail causing improper hydraulic fluid displacement. As a result, clutch slip might be experienced along with premature clutch failure. This may also cause incorrect disengagement of the clutch.

ACS recommend a total inspection of the hydraulic system ensuring the slave cylinder and master cylinder are not holding hydraulic pressure. If, after all necessary adjustments, the slave cylinder still has excessive hydraulic fluid pressure, replacement or repair should be undertaken.

Replacement slave and master cylinders are available from your ACS (ClutchPro & Xtreme) Distributor.
