# CLUTCHTECH

## TSB-269 Pivot Ball and Clutch Fork Wear

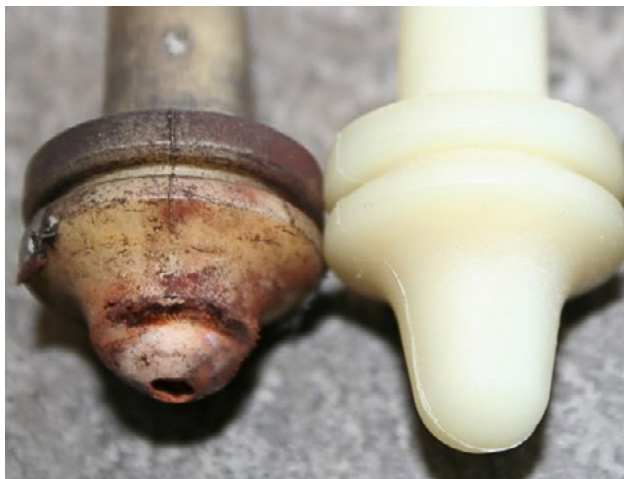
Example of a used OEM plastic pivot ball (left) & a new OEM plastic pivot ball (right) for the same application.

It is necessary to thoroughly check these components and replace them if there are any signs of wear/damage. If existing components are to be reused, they should be thoroughly cleaned and re-lubricated at all contact points.

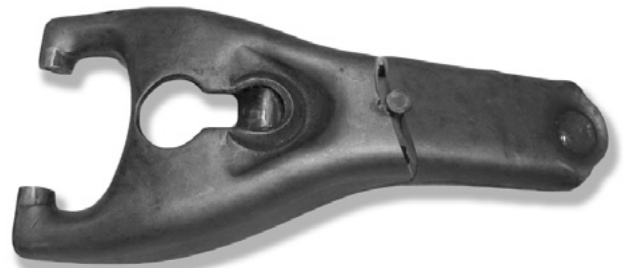
Example of a cracked fork
