SHAFTEC®

PR633 - PR635 - PR1138

Technical Information

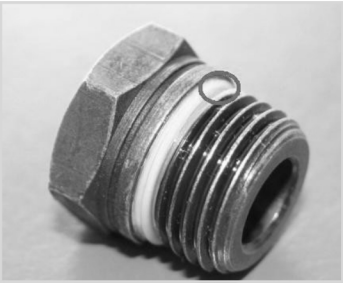
Figure 1

Care is needed when connecting the pressure feed and return pipes (figure 1). It is important not to over tighten the fitting as this will strip the thread. Please be aware that, even after the fitting is fully secured, the pipes can still be moved.

Damage to the pressure port thread caused by over tightening will invalidate the warranty.
