Technical Bulletin

Discs with ABS Rings

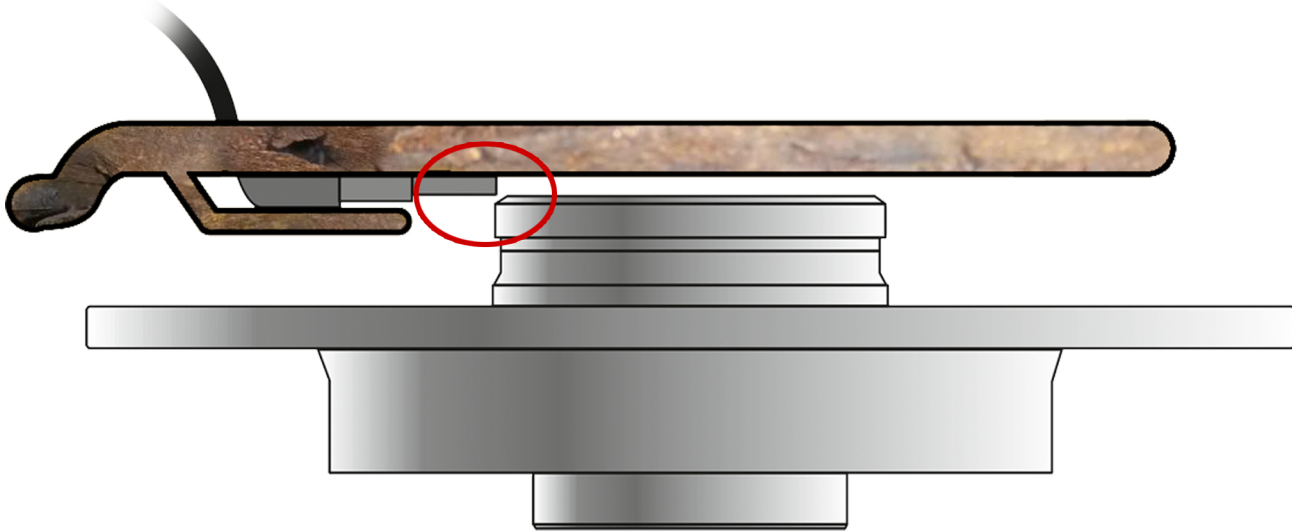
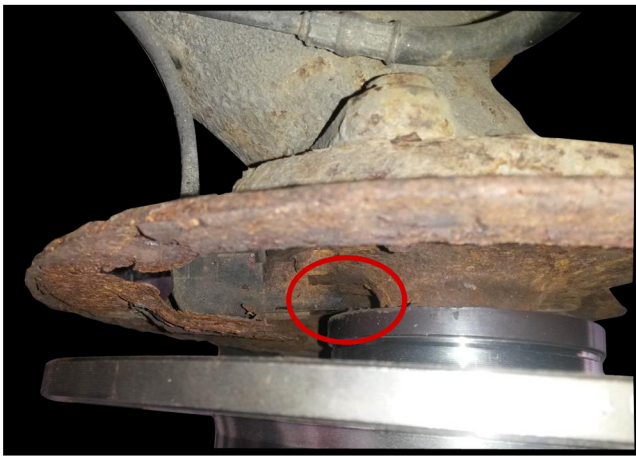
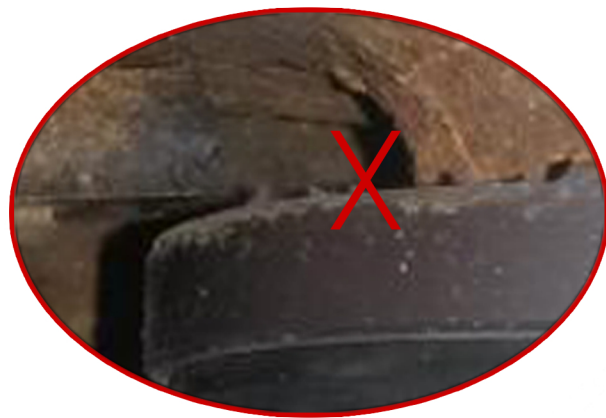
PROBLEM: When changing brake discs that have an ABS sensor fitted, the disc can at times touch the ABS sensor, and if the disc is pushed all the way in it may bend the sensor and the magnetic sensor ring on the disc can become damaged.

SOLUTION: The ABS sensor is being forced away from its correct position by the rust build up behind it on the dust cover plate.

It is advised to remove the sensor and clean away the corrosion. However if the corrosion is too severe it may be necessary to fit a new dust cover plate.
