## LuK Service Info

# Part Nr. 230 0022 11 – 280/295mm TGU6

**TB1043**

POWER TAKE OFF CLUTCH NOISE AND RELEASE  
PROBLEMS.

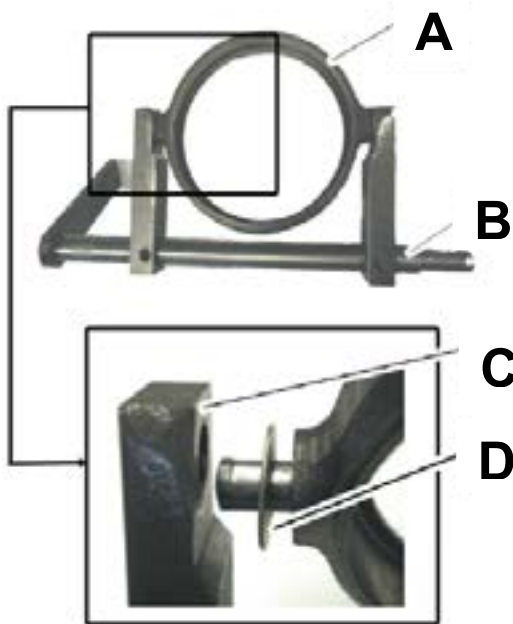
**A - Release bearing carrier**  
**B - Actuation shaft**  
**C - Release fork arm**  
**D - Thrust washer**

Excessive or uneven wear to the release bearing carrier pivots can result in failure or breakage of the PTO release bearing. Prolonged use in this condition can damage the PTO clutch release plate and levers. Uneven release movement of the clutch pressure plates causes noise and vibration. All areas of wear need to be addressed when replacing the clutch assembly.
