NEW PRODUCT HIGHLIGHT | OCT2023

febi 181505

To Fit:
Mercedes-Benz Trucks
Actros I+II+III, Atego I+II, Econic, U (405)

Electronic Accelerator Pedal

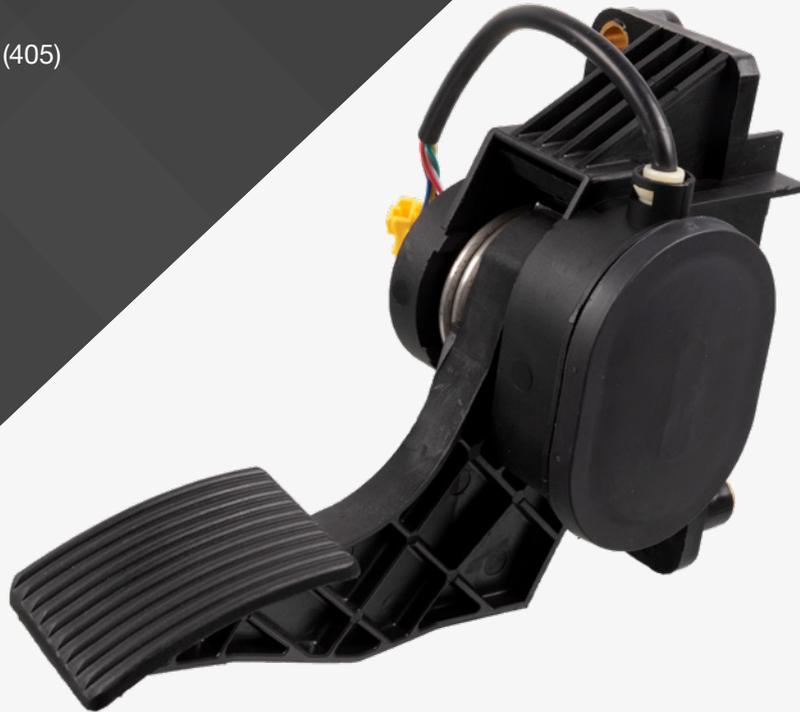
An electronic accelerator pedal communicates with a control unit via analogue or digital signals. To ensure that this communication functions correctly, a pedal value sensor is integrated in the accelerator pedal. This detects how hard the pedal is pressed and passes the information on to the engine control unit. For this purpose, two voltage values are usually transmitted. If it is a CAN bus network, digital signals are also possible.

If the electronic accelerator pedal and the engine control unit do not communicate correctly with each other, the desired engine power can no longer be called up. Usually, the vehicle goes into an emergency running programme with increased idling and a warning message is displayed to the driver. These symptoms do not necessarily mean a defect in the electronic accelerator pedal. A damaged cable, a malfunctioning connection or a voltage that is not applied can also be the cause. If these things have all been checked and are free of faults, it is usually a defect of the pedal value sensor. Since a repair would not be economically viable, the electronic accelerator pedal must be replaced.
