# TECHNICAL REPORT

Repair kit for Renault Zoe  
electric motor reference  
77038500

## 02 set reference 77038500

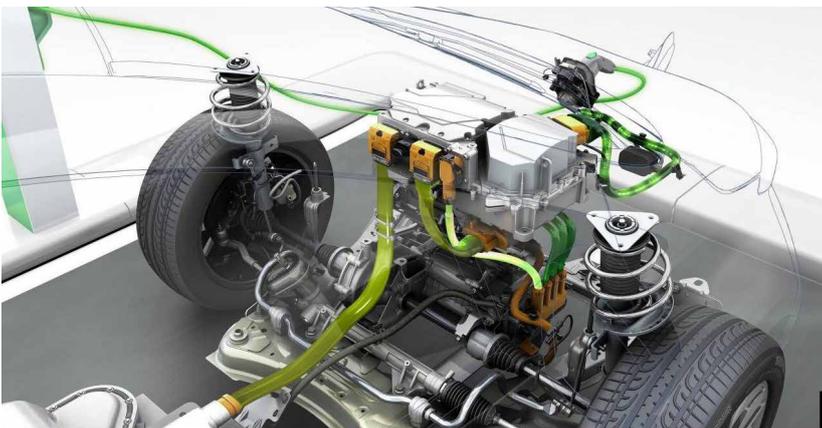
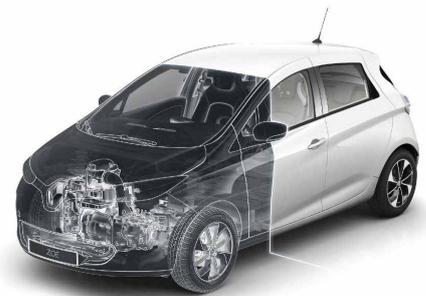
This is where **our electric motor repair** kit plays a key role, since it comes to solve a problem with the engine of the first generation RENAULT ZOE, code 5AM-450.

This motor designed by Continental has the peculiarity of **having brushes to transfer** the electrical voltage to the rotor.

These brushes, due to their operation, **tend to wear out** when in contact with the metal tracks of the rotor. They are mainly made of graphite, and the problem comes when this worn material becomes embedded in one of the rotor bearings, due to its proximity, making the motor starts to turn with greater difficulty.

For these reasons it is common to have to repair the engine **by replacing the bearing**, and the gasket that is housed in that area.

Ajusa **offers one set for sale**, for the specific reparation of this breakdown, consisting of a bearing and an electric motor gasket.

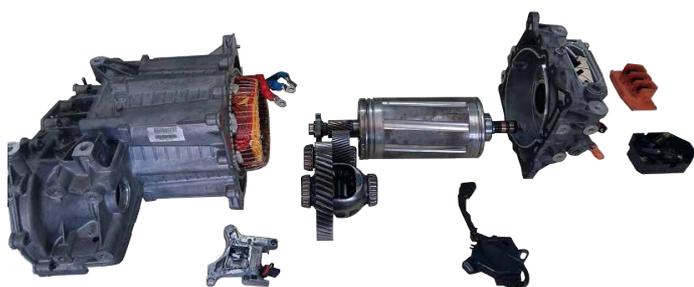
In the long run, this generates a **higher temperature** in the area, which can deform the stator casing and to cause failure of the gasket that seals the engine cooling system, with this coolant reaching the stator area, and therefore both causing an insulation failure that prevents it from continuing to function
