TSB-257

Mazda 3 Clutch Fork

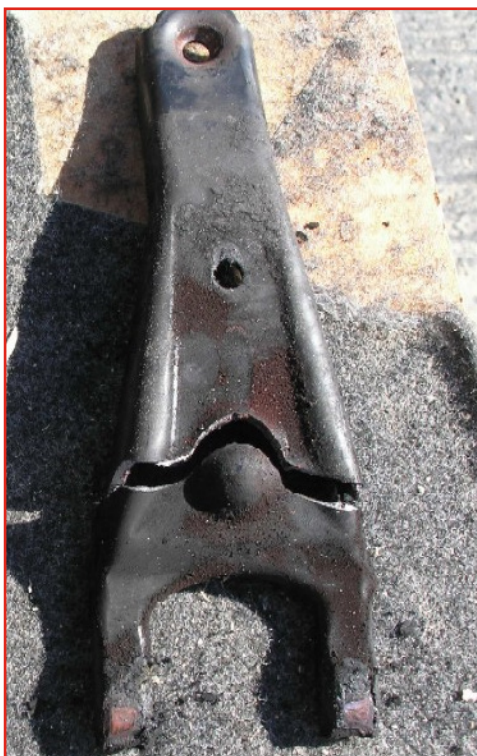
Clutch forks can fracture after excessive wear. It is important to check all points of contact when inspecting them.

In some Mazda 3 models, the original clutch fork is prone to failure. Therefore, it is highly recommended to inspect all of the components and check for any signs of wear or fatigue/damage prior to fitting a clutch. If there are signs of wear, these components should be replaced to prevent an issue from occurring in the future.

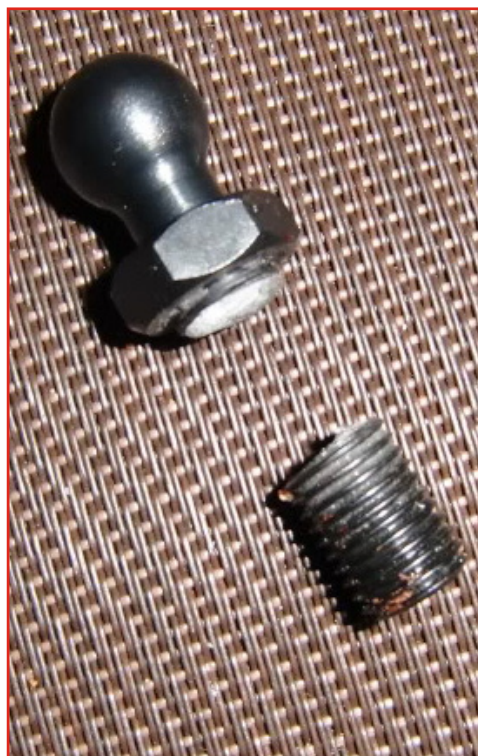
Pivot balls can become shorter or completely shear as a result of wear. Carefully check for any damage.

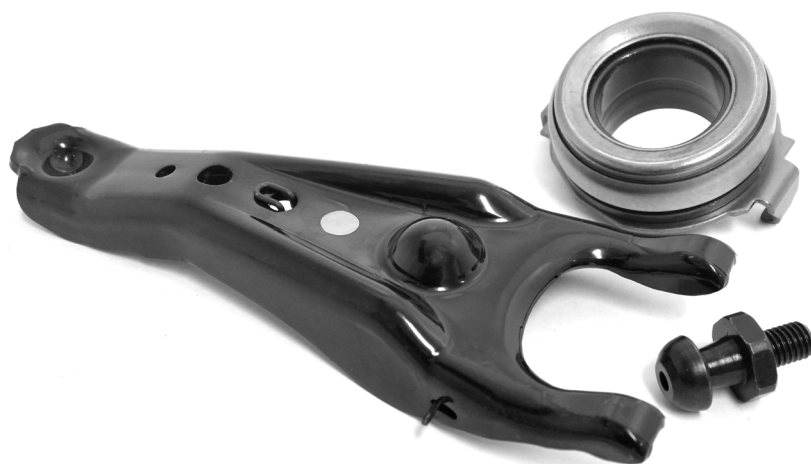
Australian Clutch Services offer a replacement kit – ATFMZ01 including clutch fork, pivot ball and release bearing. The clutch fork and bearing are of a different design to OE and are significantly stronger.
