CLUTCHTECH

TSB-287

T5 Gearbox Bellhousing Modification

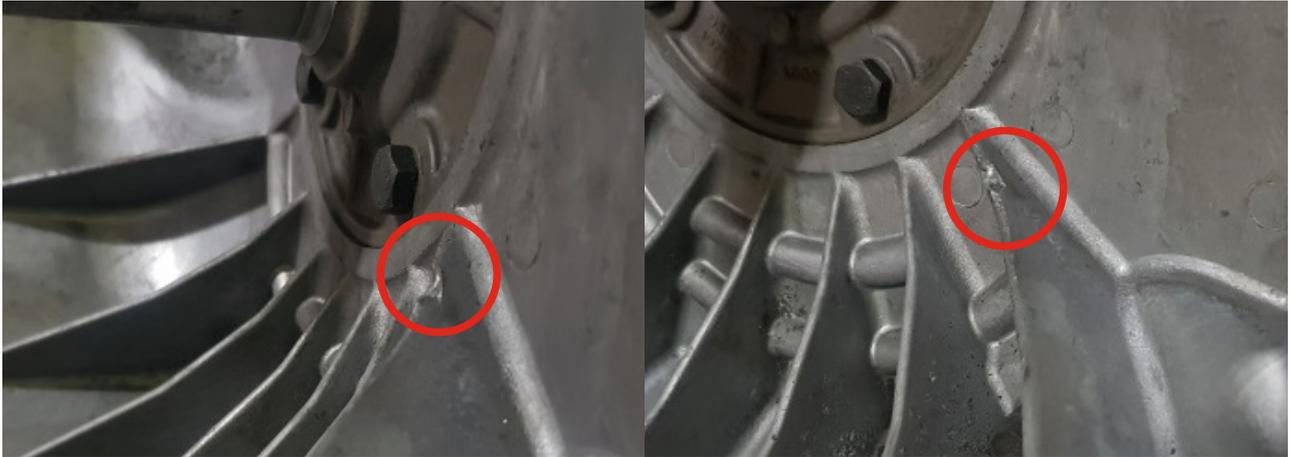
For some T5 gearboxes, the fork and bellhousing ribs can come into contact as the clutch wears and pushes the fork back. Witness marks may be visible, similar to the below photos circled in red.

To allow for maximum fork movement and clutch wear, ACS recommends making a modification to the bellhousing ribs by grinding away a small section to avoid contact with the fork as shown in the below photos. Remove any sharp edges and burrs and test fit the fork prior to reinstallation of the clutch.
