TSB-FD16

Engine to Gearbox Mis-alignment Vehicle; Ford Transit 2.4L T/Diesel (6 Speed)

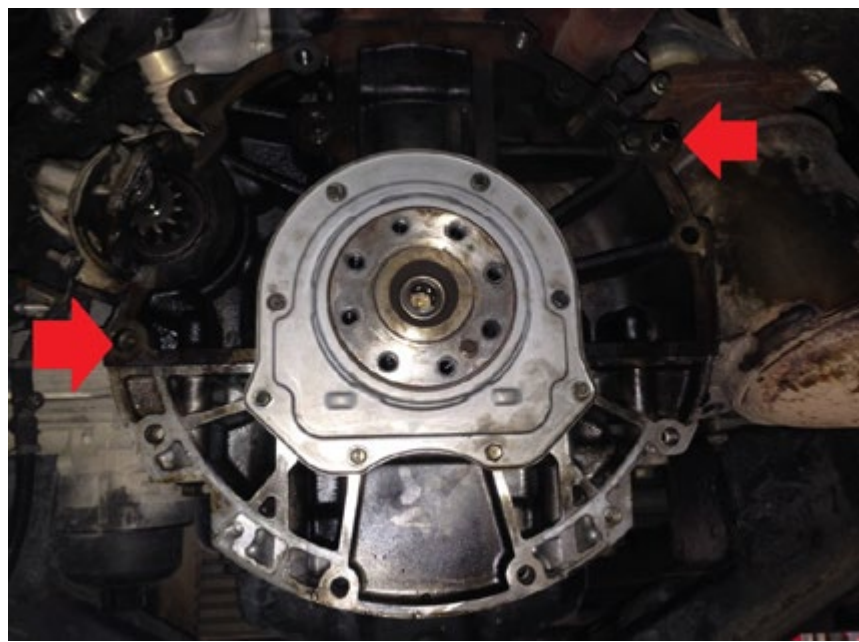
It has been identified that failing to align the gearbox to the engine correctly on a 6 speed Ford Transit can cause premature clutch failure. The below image shows the back of the Ford Transit engine, which requires 2 dowels to align the gearbox to the engine correctly.

If 1 or more dowels are missing it can cause the clutch disc to absorb the mis-alignment. This overload will cause a premature fatigue of the clutch disc.

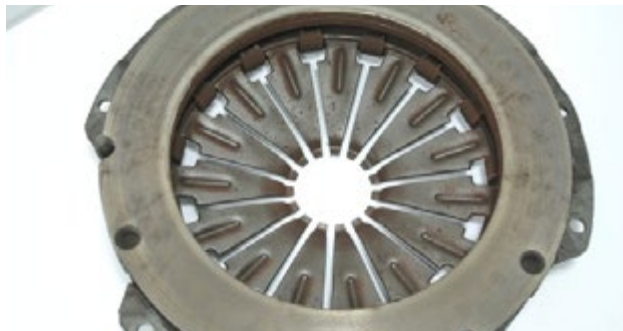
High levels of red dust

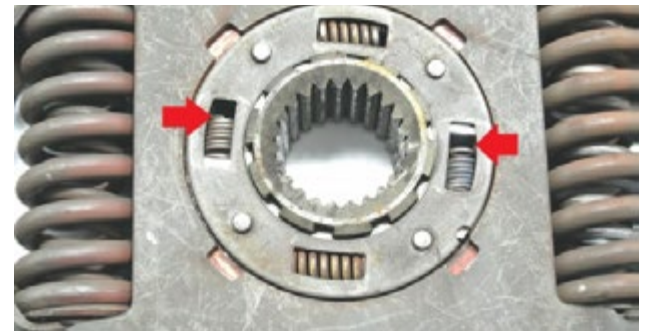
Clutch disc idle spring failure
