# CLUTCHTECH

## TSB - SU02

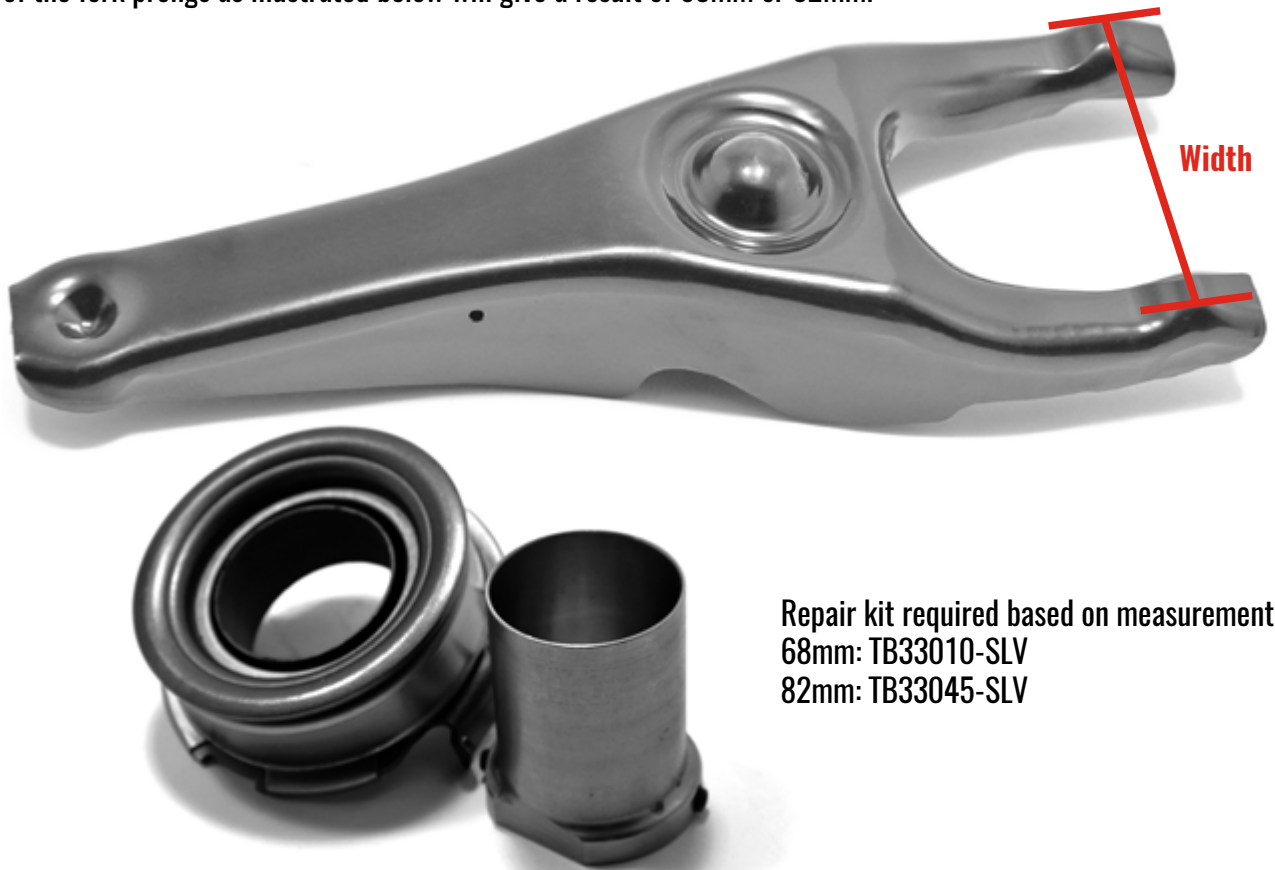
It's common for this vehicle to develop excessive wear on the nose cone (bearing slide) on the transmission. Check the nose cone visually for wear before fitting the new bearing.

Symptoms of a worn nose cone:

- Clutch Pedal Vibration
- Notchy Pedal
- Hard/ Heavy Pedal

If your vehicle exhibits any of these symptoms or visually shows wear, ClutchPro recommends fitting a repair sleeve kit. There are 2 kits available depending on the clutch fork in the vehicle. Measuring the outside width of the fork prongs as illustrated below will give a result of 68mm or 82mm.

Repair kit required based on measurement:  
68mm: TB33010-SLV  
82mm: TB33045-SLV
